DEPARTMENT OF TRANSPORTATION

Contract #: 04-0120F4Cty: SF/ALA Rte: 80 PM: 13.2/13.9File #: 1.28**WELDING INSPECTION REPORT****Resident Engineer:** Pursell, Gary**Address:** 333 Burma Road**City:** Oakland, CA 94607**Report No:** WIR-016295**Date Inspected:** 18-Aug-2010**Project Name:** SAS Superstructure**OSM Arrival Time:** 700**Prime Contractor:** American Bridge/Fluor Enterprises, a JV**OSM Departure Time:** 1530**Contractor:** American Bridge/Fluor Enterprises, a JV**Location:** Jobsite**CWI Name:** See below**CWI Present:** Yes No**Inspected CWI report:** Yes No N/A**Rod Oven in Use:** Yes No N/A**Electrode to specification:** Yes No N/A**Weld Procedures Followed:** Yes No N/A**Qualified Welders:** Yes No N/A**Verified Joint Fit-up:** Yes No N/A**Approved Drawings:** Yes No N/A**Approved WPS:** Yes No N/A**Delayed / Cancelled:** Yes No N/A**Bridge No:** 34-0006**Component:** SAS OBG**Summary of Items Observed:**

3). OBG Field Splice 5W/6W Weld ID: C1, Face A

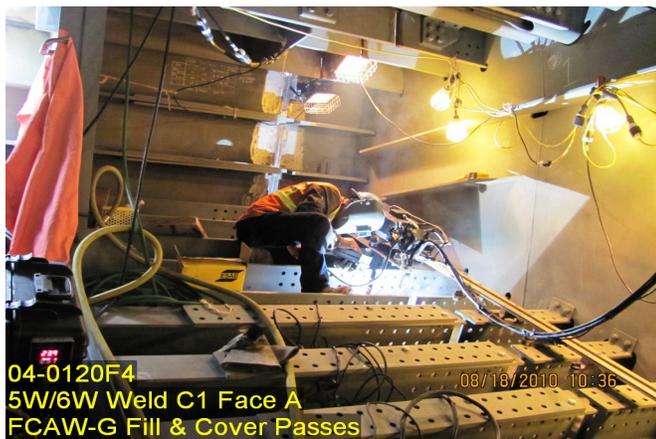
The QAI periodically observed AB/F approved welder Song Tao Huang (ID 3794) performing welding per the Flux Cored Arc Welding (FCAW-G) process in the 3G (vertical) position of fill and cover passes on weld ID: C1. See photo below. The QAI observed QC Inspector Tony Sherwood was present to monitor the progress and verify that the welding parameters were within the limits established by the approved welding Procedure Specification (WPS) identified as ABF-WPS-D1.5-3042B-1. The QAI observed the QC Inspector monitoring and recording the welding parameters and observed the following: 24.3 welding volts, 243 welding amps and travel speed of 290mm/min. The QAI observed that the work at this location appeared to be in general compliance with contract documents.
