DEPARTMENT OF TRANSPORTATION

Contract #: 04-0120F4Cty: SF/ALA Rte: 80 PM: 13.2/13.9File #: 1.28**WELDING INSPECTION REPORT****Resident Engineer:** Pursell, Gary**Address:** 333 Burma Road**City:** Oakland, CA 94607**Report No:** WIR-016296**Date Inspected:** 17-Aug-2010**Project Name:** SAS Superstructure**OSM Arrival Time:** 630**Prime Contractor:** American Bridge/Fluor Enterprises, a JV**OSM Departure Time:** 1500**Contractor:** American Bridge/Fluor Enterprises, a JV**Location:** Job Site**CWI Name:** See below**CWI Present:** Yes No**Inspected CWI report:** Yes No N/A**Rod Oven in Use:** Yes No N/A**Electrode to specification:** Yes No N/A**Weld Procedures Followed:** Yes No N/A**Qualified Welders:** Yes No N/A**Verified Joint Fit-up:** Yes No N/A**Approved Drawings:** Yes No N/A**Approved WPS:** Yes No N/A**Delayed / Cancelled:** Yes No N/A**Bridge No:** 34-0006**Component:** SAS OBG**Summary of Items Observed:**

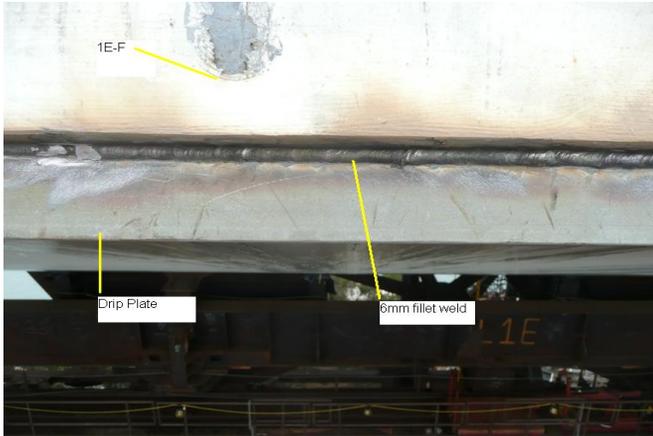
1E Drip Edge Installation

Upon the arrival of the QA Inspector, it was observed both of the drip plates had been installed to the directly under the "F" edge plate. The QA Inspector randomly observed the first plate had been installed with a complete joint penetration groove weld with a reinforcing fillet weld on the back side of the plate. The QA Inspector noted the second plate that was installed, was welded with a 6mm fillet weld on both sides of the plate. The ABF WQCM Jim Bowers informed the QA Inspector as per design drawing sheet 877 R1 the installation only requires a 6mm fillet weld on both sides of the plate with a seal weld at either end to the existing drip plate on the bridge. Mr. Bowers informed the QA Inspector ABF is utilizing a partial joint penetration groove weld in lieu of a seal weld to ensure no cracking would occur. The QA Inspector randomly observed the ABF welder Rick Clayborn performing the SMAW 6mm fillet weld attaching the second drip plate to the OBG. The QA Inspector randomly observed the welder to be utilizing E7018 low hydrogen electrodes with 135 Amps. The QA Inspector noted the SMAW parameters appeared to be in general compliance with ABF-WPS-D1.5-F1202.
