DEPARTMENT OF TRANSPORTATION

Quality Assurance and Source Inspection

Contract #: 04-0120F4Cty: SF/ALA Rte: 80 PM: 13.2/13.9File #: 1.28**WELDING INSPECTION REPORT****Resident Engineer:** Pursell, Gary**Address:** 333 Burma Road**City:** Oakland, CA 94607**Report No:** WIR-016300**Date Inspected:** 18-Aug-2010**Project Name:** SAS Superstructure**OSM Arrival Time:** 1000**Prime Contractor:** American Bridge/Fluor Enterprises, a JV**OSM Departure Time:** 1500**Contractor:** American Bridge/Fluor Enterprises, a JV**Location:** Job Site

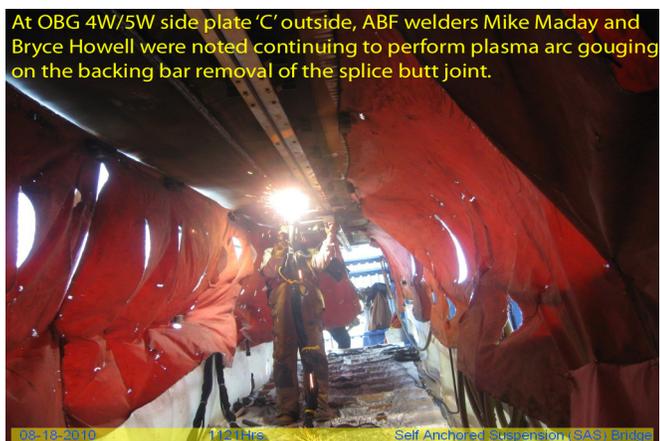
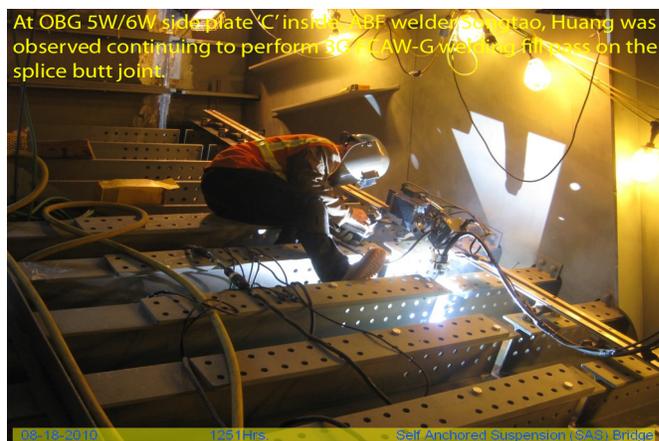
At OBG 5W/6W side plate 'C' (1000mm to 3200mm) inside, QA randomly observed ABF/JV qualified welder Sungtao, Huang ID # 3794 continuing to perform CJP groove (splice) welding fill pass on the splice butt joint. The welder was observed performing automatic welding in the 3G (vertical) position utilizing a dual shield Flux Cored Arc Welding (FCAW-G) with E71T-1M, 1/16" diameter wire electrode and implementing Caltrans approved Welding Procedure Specification (WPS) ABF-WPS-D15-3042B-1. The joint being welded had a single V-groove butt joint with backing bar. The splice joint was preheated and maintained to greater than 150 degrees Fahrenheit using Miller Proheat 35 Induction Heating System located at the opposite side of the plate prior/during welding. ABF Quality Control (QC) William Sherwood was noted monitoring the welding parameters of the welder. At the end of the shift, fill pass welding was still continuing and should remain tomorrow.

QA randomly observed ABF/JV qualified welders Rory Hogan and Jeremy Dolman continuing to perform CJP groove (splice) back welding fill pass to cover pass on Orthotropic Box Girder (OBG) 5E/6E side plate 'E1' outside. The welder was observed back welding in the 4G (overhead) position utilizing a dual shield Flux Cored Arc Welding (FCAW-G) with E71T-1M, 1/16" diameter wire electrode and implementing Caltrans approved Welding Procedure Specification (WPS) ABF-WPS-D15-3110-4. The welder was using a track mounted welder holder assembly that was remotely controlled. The joint being welded has the backing bar gouged using the Esab Plasma Arc machine and was ground smooth. The gouged and ground splice butt joint was also Non Destructive

At OBG 4W/5W side plate 'C' outside, QA randomly observed ABF personnel Mike Maday and Bryce Howell continuing to perform plasma arc gouging on the backing bar removal of the splice butt joint. The personnel were using an Esab plasma arc gouging machine that has the nozzle holder attached to a Bug-o track. Gouging of the backing bar was not completed today and should continue tomorrow.

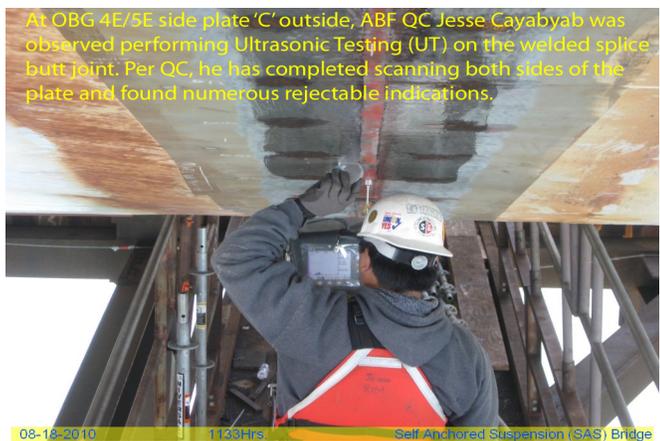
At OBG 4E/5E side plate 'C' outside, QA randomly observed ABF QC Jesse Cayabyab perform Ultrasonic Testing (UT) on the welded and flush ground cover of the splice butt joint. After the completion of his UT on the joint, QC mentioned to QA that he has completed scanning both sides of the joint (inside and outside) and that QC found numerous rejectable indications. According to QC, he marked those rejectable indications for repair.
