DEPARTMENT OF TRANSPORTATION

Quality Assurance and Source Inspection

Contract #: 04-0120F4Cty: SF/ALA Rte: 80 PM: 13.2/13.9File #: 69.28**WELDING INSPECTION REPORT****Resident Engineer:** Pursell, Gary**Address:** 333 Burma Road**City:** Oakland, CA 94607**Report No:** WIR-016307**Date Inspected:** 20-Aug-2010**Project Name:** SAS Superstructure**OSM Arrival Time:** 700**Prime Contractor:** American Bridge/Fluor Enterprises, a JV**OSM Departure Time:** 1900**Contractor:** Zhenhua Port Machinery Company, Ltd (ZPMC), Changxing Island **Location:** Shanghai, China**CWI Name:** Zhu Zhong Hai.**CWI Present:** Yes No**Inspected CWI report:** Yes No N/A**Rod Oven in Use:** Yes No N/A**Electrode to specification:** Yes No N/A**Weld Procedures Followed:** Yes No N/A**Qualified Welders:** Yes No N/A**Verified Joint Fit-up:** Yes No N/A**Approved Drawings:** Yes No N/A**Approved WPS:** Yes No N/A**Delayed / Cancelled:** Yes No N/A**Bridge No:** 34-0006**Component:** OBG components.**Summary of Items Observed:**

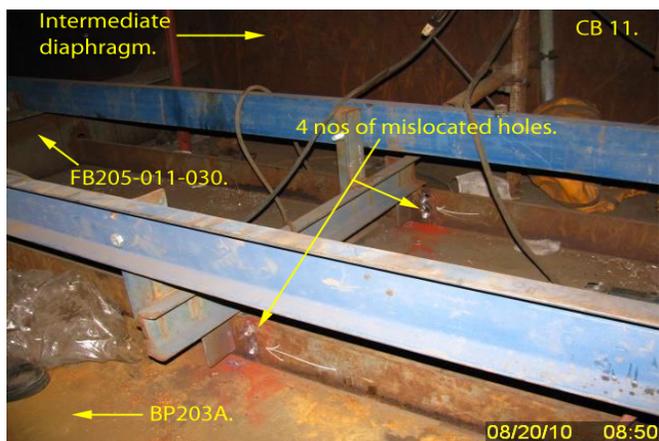
Cross Beam 11 (CB11):

- 1) ZPMC personnel doing base metal repair welding (weld restoration of base metal due to mislocated holes).
- 2) Total 4 nos of mislocated holes were identified.
- 3) 2 nos on one of the I-rib on Bottom Panel (BP) BP203A and 2 nos on another I-rib on BP201A. See attached photo for further details.
- 4) This repair welding was done as per WRR: B-WR-14631 Rev-0.
- 5) Welding process was identified as SMAW. The welder is identified as 058087 and was observed welding in the 3G position. The welding variables recorded by QC appeared to comply with WPS: 345-SMAW-3G(3F)-Repair-Mislocated holes.

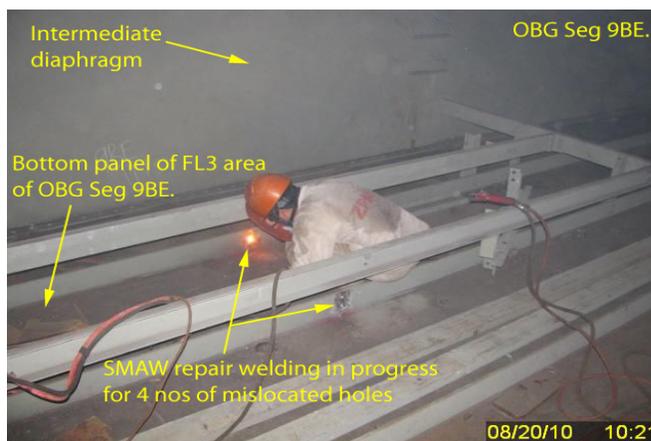
OBG Seg 9BE:

- 1) ZPMC personnel doing base metal repair welding (weld restoration of base metal due to mislocated holes).

- 2) Total 4 nos of mislocated holes were identified on I-rib (X115A) on BP26A (See attached photo for further details).
- 3) This repair welding was done as per WRR: B-WR-14631 Rev-0.
- 4) Welding process was identified as SMAW. The welder is identified as 058087 and was observed welding in the 3G position. The welding variables recorded by QC appeared to comply with WPS: 345-SMAW-3G(3F)-Repair-Mislocated holes.
