**DEPARTMENT OF TRANSPORTATION**

Contract #: 04-0120F4Cty: SF/ALA Rte: 80 PM: 13.2/13.9File #: 69.28**WELDING INSPECTION REPORT****Resident Engineer:** Pursell, Gary**Address:** 333 Burma Road**City:** Oakland, CA 94607**Report No:** WIR-016317**Date Inspected:** 17-Aug-2010**Project Name:** SAS Superstructure**OSM Arrival Time:** 1900**Prime Contractor:** American Bridge/Fluor Enterprises, a JV**OSM Departure Time:** 700**Contractor:** Zhenhua Port Machinery Company, Ltd (ZPMC), Changxing Island **Location:** Shanghai, China**CWI Name:** See Below**CWI Present:** Yes No**Inspected CWI report:** Yes No N/A**Rod Oven in Use:** Yes No N/A**Electrode to specification:** Yes No N/A**Weld Procedures Followed:** Yes No N/A**Qualified Welders:** Yes No N/A**Verified Joint Fit-up:** Yes No N/A**Approved Drawings:** Yes No N/A**Approved WPS:** Yes No N/A**Delayed / Cancelled:** Yes No N/A**Bridge No:** 34-0006**Component:** OBG**Summary of Items Observed:**

**OBG Segment Trial Assembly**

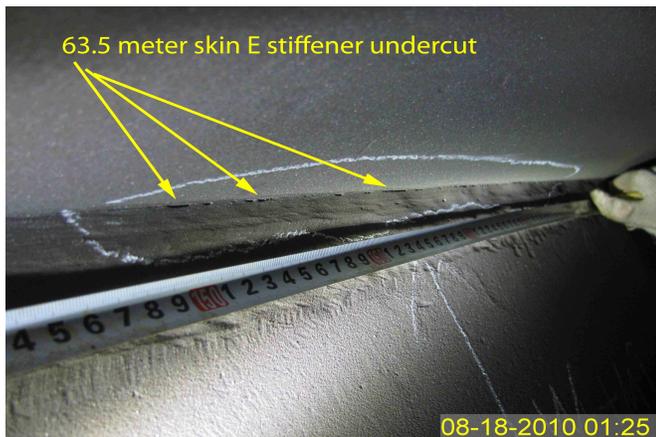
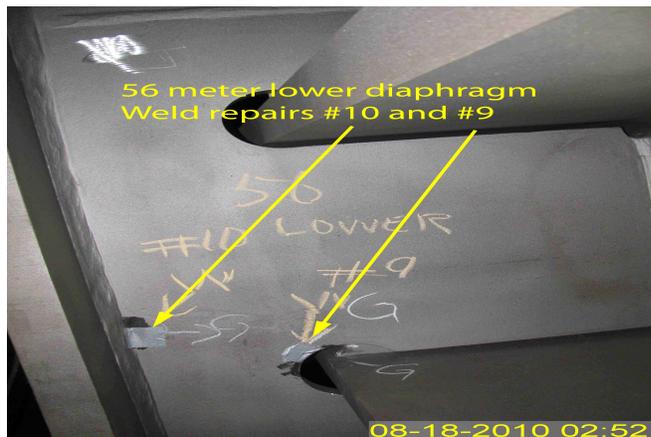
ZPMC requested Caltrans personnel to perform visual inspections of East Tower Lift 2 between the 65M upper double diaphragm and the end of the shaft at 83M (7 sections) on August 18, 2010 at around 00:30 hours following the initial pre-blast cleaning of the steel surfaces. When Caltrans QA Inspectors George Goulet, Mike Hasler and this QA Inspector arrived at the East Tower Lift 2 ABF representative Mr. Kim Xiao stated that the original notification was incorrect and that the areas which require visually inspections are from the 50 meter end of the East Tower Lift 2 to the 65M upper double diaphragm. This QA Inspector visually observed approximately 40 locations that required grinding to resolve visual weld spatter, arc strikes, shallow nicks, scrapes, and other minor surface rejections and two locations which require weld repairs. ABF and ZPMC Inspectors also performed visual inspections of the areas indicated above and a total of sixteen areas were identified as needing weld repairs. A "Blast Inspection" incident report has been issued to document these repairs and below is a total list of the weld repairs that were observed by all Inspectors.

- 1- Skin "A" / "B" corner weld porosity approx. elevation: 63 meters.
- 2- Base metal gouge approx. elevation: 51.40 meters
- 3- 53 meter bottom diaphragm base material notch near fit lug weld ESD1-TL7C/L-17

- 4- 53 meter diaphragm to fit lug weld ESD1-TL7C/L-23 has porosity
- 5- 53 meter diaphragm to skin "B" weld ESD1-TL7C/L-28 has porosity
- 6- 59 meter diaphragm to skin "B" weld ESD1-TL7D/L-66 has porosity

- 7- 59 meter diaphragm to skin "B" weld ESD1-TL7D/L-65 has porosity
- 8- 59 meter diaphragm to fit lug weld ESD1-TL7D/L-25 has porosity
- 9- Lower 56m diaphragm base material is gouged.

- 10- Lower 56m diaphragm base material is gouged.
- 11- 53 meter skin E stiffener nearest "D" / "E" corner has base material gouge adjacent to bolt hole

- 12- 59.75 meter base material gouge in skin plate "D" at weld relief cope hole of stiffener D-1
- 13- 65 meter lower diaphragm to skin E weld ESD1-TL7E/L-91 has porosity at end of weld near weld - ESD1-TL7E/L-104.

- 14- 63.5 meter skin E stiffener weld has undercut 1.5 meters below 65 meter diaphragm, 400 mm long 3rd stiff from skin D.
- 15- Porosity bottom of 65m diaphragm weld to skin "C" weld ESD1-TL7E/L-153

16- Porosity bottom of 65m diaphragm weld to skin "C" weld ESD1-TL7E/L-157
