DEPARTMENT OF TRANSPORTATION

Contract #: 04-0120F4Cty: SF/Ala Rte: 80 PM: 13.2/13.9File #: 69.28**WELDING INSPECTION REPORT****Resident Engineer:** Pursell, Gary**Address:** 333 Burma Road**City:** Oakland, CA 94607**Report No:** WIR-016322**Date Inspected:** 09-Aug-2010**Project Name:** SAS Superstructure**OSM Arrival Time:** 1900**Prime Contractor:** American Bridge/Fluor Enterprises, a JV**OSM Departure Time:** 700**Contractor:** Zhenhua Port Machinery Company, Ltd (ZPMC), Changxing Island **Location:** Shanghai, China**CWI Name:** See below**CWI Present:** Yes No**Inspected CWI report:** Yes No N/A**Rod Oven in Use:** Yes No N/A**Electrode to specification:** Yes No N/A**Weld Procedures Followed:** Yes No N/A**Qualified Welders:** Yes No N/A**Verified Joint Fit-up:** Yes No N/A**Approved Drawings:** Yes No N/A**Approved WPS:** Yes No N/A**Delayed / Cancelled:** Yes No N/A**Bridge No:** 34-0006**Component:** Tower Components**Summary of Items Observed:**

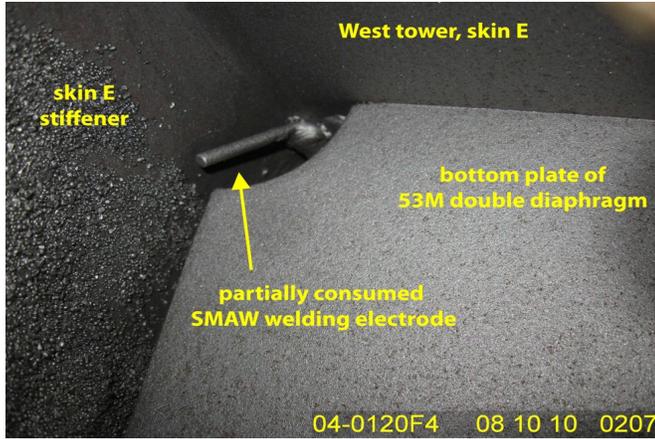
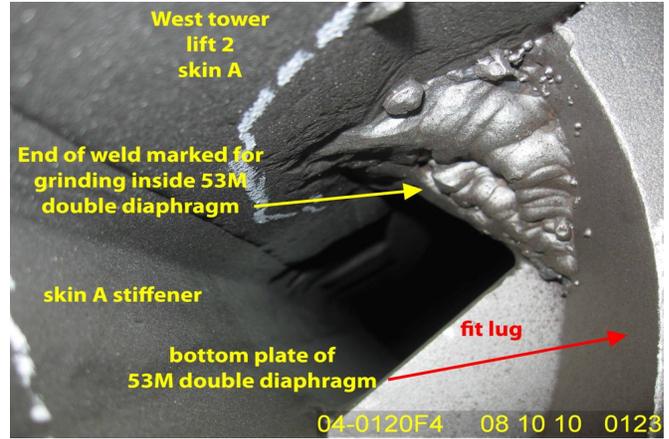
ZPMC requested Caltrans personnel to perform visual inspections of west tower, lift 2 from 50.3M elevation, the bottom of lift 2, to the bottom of 56M single diaphragm and from the top of 77M double diaphragm to 83M elevation, the top of lift 2. At approximately 0030 hours following the initial blast cleaning of the steel surfaces, Caltrans QA Inspectors Ken Riley, Mike Hasler and this QA Inspector performed random visual inspections of these areas. ABF and ZPMC Inspectors were present and performing visual inspections of the areas noted above. This QA Inspector visually observed several areas that have light areas of rust which indicates the grit blasting was not adequate to prepare the metal surfaces prior to application of paint and approximately 40 locations that required grinding to resolve visual weld spatter, arc strikes, shallow nicks, scrapes, rough edges of unground welds, and sharp edges of ground welds. Two partially consumed SMAW welding electrodes were also observed extending out from weld joints. See photos below. Approximately 20 locations were marked by ZPMC QC, ABF and/or Caltrans Inspectors, other than this QA Inspector, as needing to be weld repaired. These weld repair areas were clearly marked, photographed and documented. After the inspection was complete, ABF Representative Xiao Jun Peng (ABF1) informed this QA Inspector that the areas requiring grinding and magnetic particle inspection (MT) only were ready for re-inspection. This QA Inspector randomly re-inspected the above noted elevations and observed all areas marked for grinding only appeared to now be in compliance with contract documents. The areas observed that had been marked for grinding and MT had been ground smooth and appeared to have received MT by evidence of the red-dyed iron powder used for the purpose. ABF1 presented this QA Inspector with a copy of the documentation of all areas observed requiring weld repairs.
