Contract #: 04-0120F4Cty: SF/Ala Rte: 80 PM: 13.2/13.9File #: 69.28**WELDING INSPECTION REPORT****Resident Engineer:** Pursell, Gary**Address:** 333 Burma Road**City:** Oakland, CA 94607**Report No:** WIR-016325**Date Inspected:** 13-Aug-2010**Project Name:** SAS Superstructure**OSM Arrival Time:** 1900**Prime Contractor:** American Bridge/Fluor Enterprises, a JV**OSM Departure Time:** 700**Contractor:** Zhenhua Port Machinery Company, Ltd (ZPMC), Changxing Island **Location:** Shanghai, China**CWI Name:** See below**CWI Present:** Yes No**Inspected CWI report:** Yes No N/A**Rod Oven in Use:** Yes No N/A**Electrode to specification:** Yes No N/A**Weld Procedures Followed:** Yes No N/A**Qualified Welders:** Yes No N/A**Verified Joint Fit-up:** Yes No N/A**Approved Drawings:** Yes No N/A**Approved WPS:** Yes No N/A**Delayed / Cancelled:** Yes No N/A**Bridge No:** 34-0006**Component:** Tower Components**Summary of Items Observed:**

WELDING INSPECTION REPORT

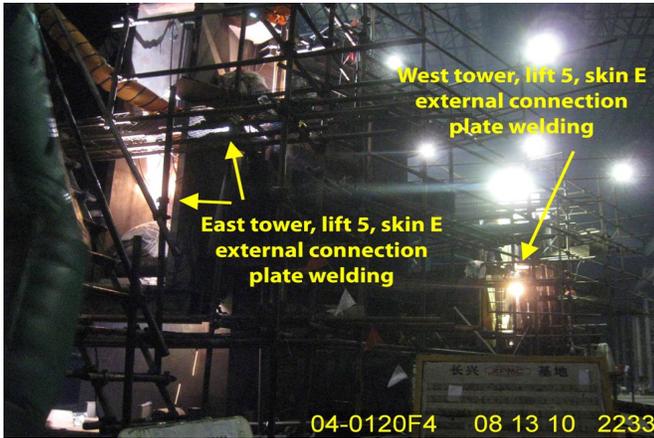
SMAW welding of weld joint WSD1-TL5-4B/F-8 located on PCMK west tower, lift 5, external connection plate to skin E. Alternating welders were identified as 066418, 066763. QC was identified as QC1. Assisting QC1 at this location and appearing to be monitoring the welding and recording data was ZPMC QC Shao Hai Lang (QCA2), who was not a CWI. Welding variables recorded by QCA2 appeared to comply with WPS-B-T-3213-TC-U4c. See photo below.

SMAW welding of weld joint WSD1-TL5-4B/F-7 located on PCMK west tower, lift 5, external connection plate to skin E. Alternating welders were identified as 066398, 066401. QC was identified as QC1. Assisting QC1 at this location and appearing to be monitoring the welding and recording data was QCA2, who was not a CWI. Welding variables recorded by QCA2 appeared to comply with WPS-B-T-3213-TC-U4c. See photo below.

SMAW welding of weld joint ESD1-TL5-2B/F-42 located on PCMK east tower, lift 5, external connection plate to skin E. Alternating welders were identified as 040667, 040614. QC was identified as QC1. Assisting QC1 at this location and appearing to be monitoring the welding and recording data was QCA2, who was not a CWI. Welding variables recorded by QCA2 appeared to comply with WPS-B-T-3213-TC-U4c. See photo below.
