DEPARTMENT OF TRANSPORTATION

Contract #: 04-0120F4Cty: SF/ALA Rte: 80 PM: 13.2/13.9File #: 1.28**WELDING INSPECTION REPORT****Resident Engineer:** Pursell, Gary**Address:** 333 Burma Road**City:** Oakland, CA 94607**Report No:** WIR-016337**Date Inspected:** 19-Aug-2010**Project Name:** SAS Superstructure**OSM Arrival Time:** 1000**Prime Contractor:** American Bridge/Fluor Enterprises, a JV**OSM Departure Time:** 1830**Contractor:** American Bridge/Fluor Enterprises, a JV**Location:** Job Site

WELDING INSPECTION REPORT

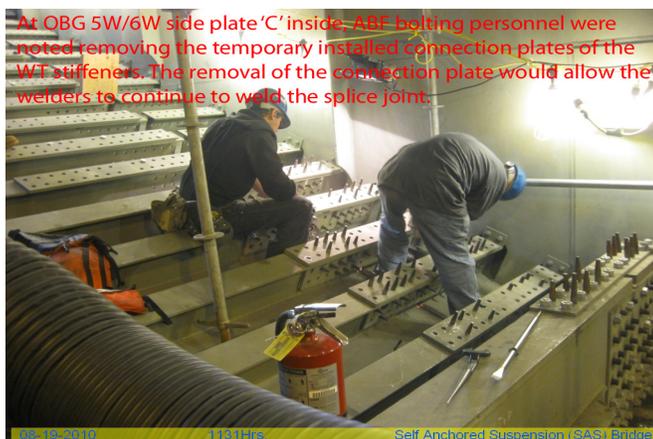
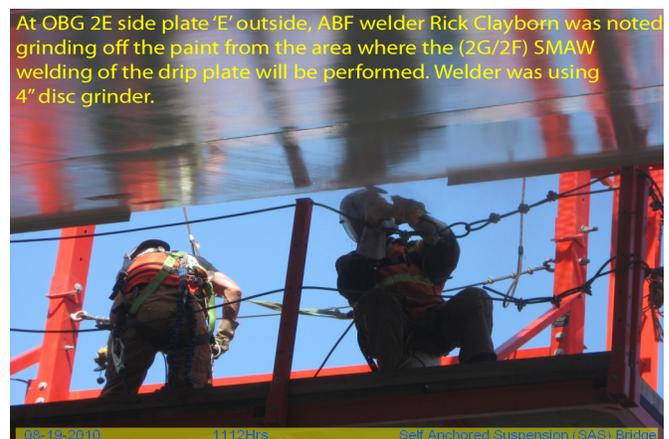
At OBG 5E/6E bottom plate 'D' outside, QA randomly observed ABF personnel Jeremy Dolman and Rory Hogan perform plasma arc gouging on the backing bar removal of the splice butt joint. The personnel were using an Esab plasma arc gouging machine that has the nozzle holder attached to a Bug-o track. Gouging of the backing bar was not completed today and should continue tomorrow.

At OBG 2E to 3E side plate 'E' outside, QA randomly observed ABF welder Rick Clayborn perform fillet and partial joint penetration (PJP) welding in 2F/2G position using Shielded Metal Arc Welding (SMAW) with 1/8" diameter E7018H4R electrode. The welder was welding on 2 1/4" wide x 3/8" thick drip plate to the side plate of the OBG. The drip plate and the surface of the side plate (where the drip plate was welded) were noted ground and the paint coating removed. ABF QC Jim Cunningham was noted monitoring the welding and its parameters. At the end of the shift, fillet and PJP welding were still continuing and should continue tomorrow.

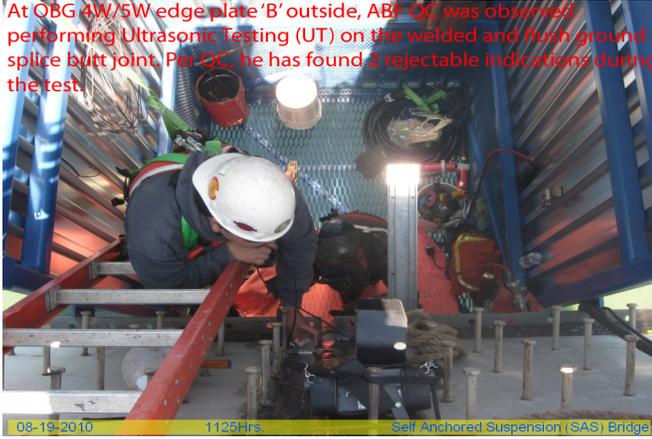
At OBG 4W/5W edge plate 'B' outside, ABF QC was observed performing Ultrasonic Testing (UT) on the welded and flush ground splice butt joint. Per QC, he has found 2 rejectable indications during the test.
