DEPARTMENT OF TRANSPORTATION

Contract #: 04-0120F4Cty: SF/ALA Rte: 80 PM: 13.2/13.9File #: 69.28**WELDING INSPECTION REPORT****Resident Engineer:** Pursell, Gary**Address:** 333 Burma Road**City:** Oakland, CA 94607**Report No:** WIR-016347**Date Inspected:** 09-Aug-2010**Project Name:** SAS Superstructure**OSM Arrival Time:** 700**Prime Contractor:** American Bridge/Fluor Enterprises, a JV**OSM Departure Time:** 1900**Contractor:** Zhenhua Port Machinery Company, Ltd (ZPMC), Changxing Island **Location:** Shanghai, China**CWI Name:** Mr. Qiu Wen**CWI Present:** Yes No**Inspected CWI report:** Yes No N/A**Rod Oven in Use:** Yes No N/A**Electrode to specification:** Yes No N/A**Weld Procedures Followed:** Yes No N/A**Qualified Welders:** Yes No N/A**Verified Joint Fit-up:** Yes No N/A**Approved Drawings:** Yes No N/A**Approved WPS:** Yes No N/A**Delayed / Cancelled:** Yes No N/A**Bridge No:** 34-0006**Component:** Tower and Orthotropic Box Girder (OBG)**Summary of Items Observed:**

On this day CALTRANS OSM Quality Assurance (QA) Inspector Shailesh Gaikwad was present during the times noted above for observations relative to the fabrication of the SAS Superstructure being performed

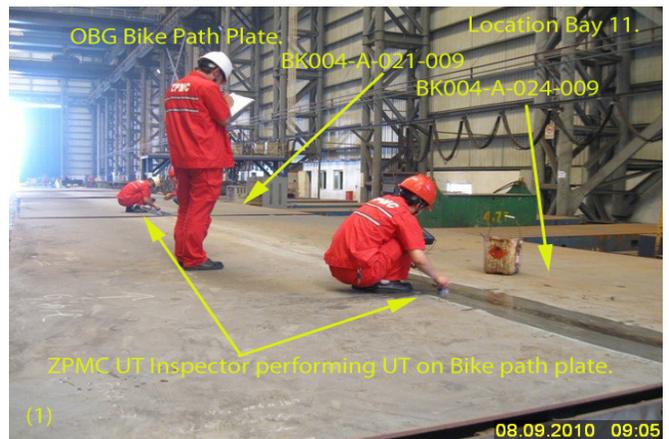
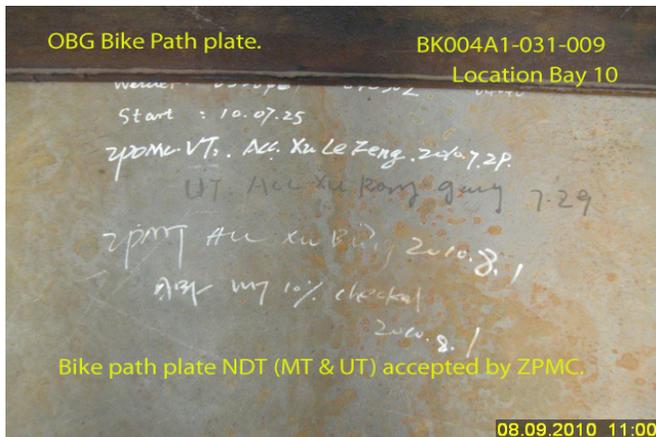
During random visual inspection in Bay 10, this Quality Assurance Inspector (QA) discovered the following issue: ZPMC personnel performed heat straightening on OBG Bike path plate after NDT (MT & UT) acceptance by ZPMC and Caltrans. The effected Bike path Plate is identified as BK004A1-031-009. The Green Tag is issued, Green Tag #13684-1. The member is non Seismic Performance Critical Member (NON SPCM). The Heat straightening report number is- HSR1 (B)-8907. The Material thickness is 16 mm. This Bike path Plate is located in Sub assembly Bay#10. For further information, please see the attached pictures below.
