**DEPARTMENT OF TRANSPORTATION**

Office of Structural Materials

Contract #: 04-0120F4Cty: SF/ALA Rte: 80 PM: 13.2/13.9File #: 69.28**WELDING INSPECTION REPORT****Resident Engineer:** Pursell, Gary**Address:** 333 Burma Road**City:** Oakland, CA 94607**Report No:** WIR-016364**Date Inspected:** 11-Aug-2010**Project Name:** SAS Superstructure**OSM Arrival Time:** 700**Prime Contractor:** American Bridge/Fluor Enterprises, a JV**OSM Departure Time:** 1900**Contractor:** Zhenhua Port Machinery Company, Ltd (ZPMC), Changxing Island **Location:** Shanghai, China**CWI Name:** Qiu Wen**CWI Present:** Yes No**Inspected CWI report:** Yes No N/A**Rod Oven in Use:** Yes No N/A**Electrode to specification:** Yes No N/A**Weld Procedures Followed:** Yes No N/A**Qualified Welders:** Yes No N/A**Verified Joint Fit-up:** Yes No N/A**Approved Drawings:** Yes No N/A**Approved WPS:** Yes No N/A**Delayed / Cancelled:** Yes No N/A**Bridge No:** 34-0006**Component:** Tower & OBG Components**Summary of Items Observed:**

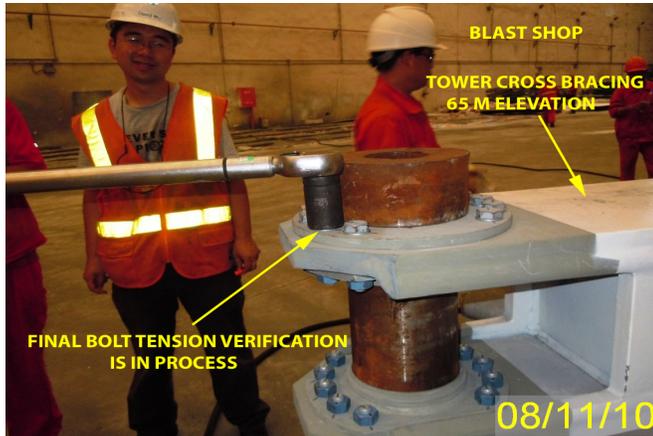
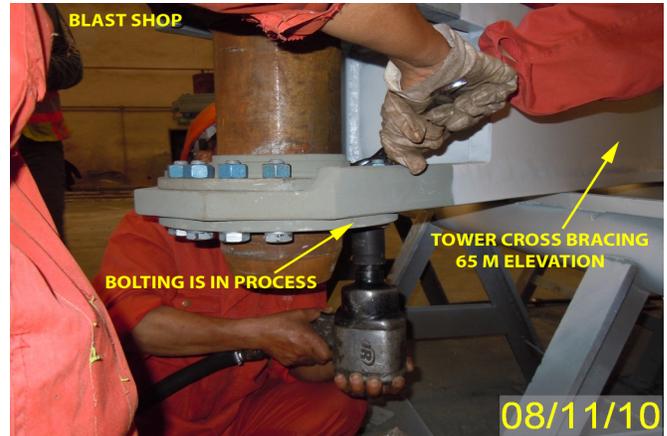
This QA Inspector witnessed final Bolt tension verification approximately 10% for the Lift 2 Tower cross bracings

of 65 meter elevation. Final tension verification found to be in general compliance.

Bolt sizes used were 3/4x3 3/4 inch, RC Set# DHGM 60625 and final torque value was 487 N-m.

Manual Torque wrench used with serial number noted as XO2-349.
