DEPARTMENT OF TRANSPORTATION

Contract #: 04-0120F4Cty: SF/ALA Rte: 80 PM: 13.2/13.9File #: 69.28**WELDING INSPECTION REPORT****Resident Engineer:** Pursell, Gary**Address:** 333 Burma Road**City:** Oakland, CA 94607**Report No:** WIR-016376**Date Inspected:** 18-Aug-2010**Project Name:** SAS Superstructure**OSM Arrival Time:** 1900**Prime Contractor:** American Bridge/Fluor Enterprises, a JV**OSM Departure Time:** 700**Contractor:** Zhenhua Port Machinery Company, Ltd (ZPMC), Changxing Island **Location:** Shanghai, China**CWI Name:** See Below**CWI Present:** Yes No**Inspected CWI report:** Yes No N/A**Rod Oven in Use:** Yes No N/A**Electrode to specification:** Yes No N/A**Weld Procedures Followed:** Yes No N/A**Qualified Welders:** Yes No N/A**Verified Joint Fit-up:** Yes No N/A**Approved Drawings:** Yes No N/A**Approved WPS:** Yes No N/A**Delayed / Cancelled:** Yes No N/A**Bridge No:** 34-0006**Component:** OBG**Summary of Items Observed:**

OBG Segment Trial Assembly

Blast Shop 2

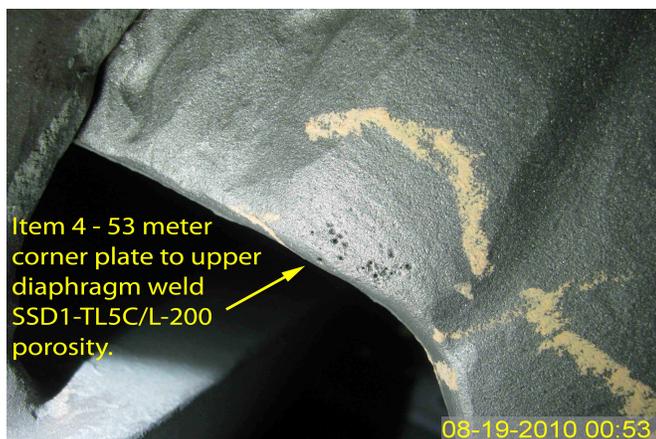
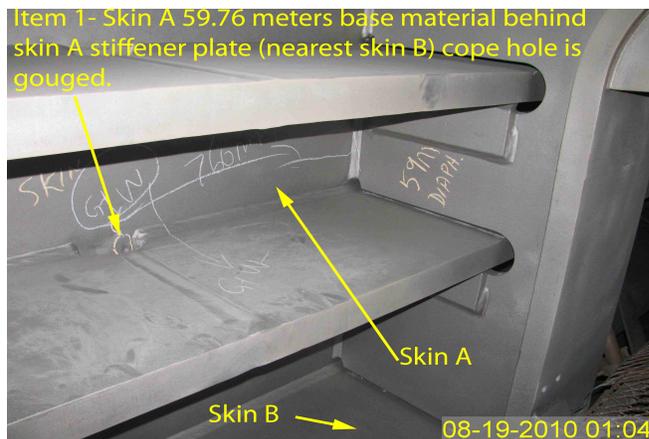
This QA Inspector visually observed approximately 30 locations that required grinding to resolve visual weld spatter, arc strikes, shallow nicks, scrapes, and other minor surface rejections and three locations which require weld repairs. ABF and ZPMC Inspectors also performed visual inspections of the areas indicated above and a total of ten areas were identified as needing weld repairs. A "Blast Inspection" incident report has been issued to document these repairs and below is a total list of the weld repairs that were observed by all Inspectors.

- 1- Skin "A" 59.76 meters base material gouge behind skin "A" stiffener plate (nearest skin "B") cope hole.
- 2- Fit lug porosity in weld SSD1-TL5C/L-78 to 53 meter diaphragm.
- 3- 53 meter upper diaphragm to skin plate "E" weld SSD1-TL5C/L-214 has porosity.
- 4- 53 meter corner plate to upper diaphragm weld SSD1-TL5C/L-200 has porosity.
- 5- Skin "E" base metal gouge 100 mm from 56 meter diaphragm near weld SSD1-TL5D/L-53.
- 6- 59 meter diaphragm, across from skin "A" has a base material gouge.
- 7- Skin "E" has porosity at 62 meter diaphragm cope hole adjacent to skin "D".
- 8- 62 meter diaphragm fit lug weld SSD1-TL5E/L-46 has porosity.
- 9- 65 meter lower diaphragm fit lug weld SSD1-TL5E/L-67 has porosity.
- 10- 65 meter lower diaphragm fit lug weld SSD1-TL5E/L-70 has porosity.

Item #11 was added to address a 150mm x 150mm piece of steel which is wedged behind 65 meter lower diaphragm near fit lug weld SSD1-TL5E/L-77.
