**DEPARTMENT OF TRANSPORTATION**

Contract #: 04-0120F4Cty: SF/ALA Rte: 80 PM: 13.2/13.9File #: 1.28**WELDING INSPECTION REPORT****Resident Engineer:** Pursell, Gary**Address:** 333 Burma Road**City:** Oakland, CA 94607**Report No:** WIR-016382**Date Inspected:** 19-Aug-2010**Project Name:** SAS Superstructure**OSM Arrival Time:** 700**Prime Contractor:** American Bridge/Fluor Enterprises, a JV**OSM Departure Time:** 1100**Contractor:** American Bridge/Fluor Enterprises, a JV**Location:** Job Site

**Bridge No:** 34-0006**Component:** OBG Section**Summary of Items Observed:**

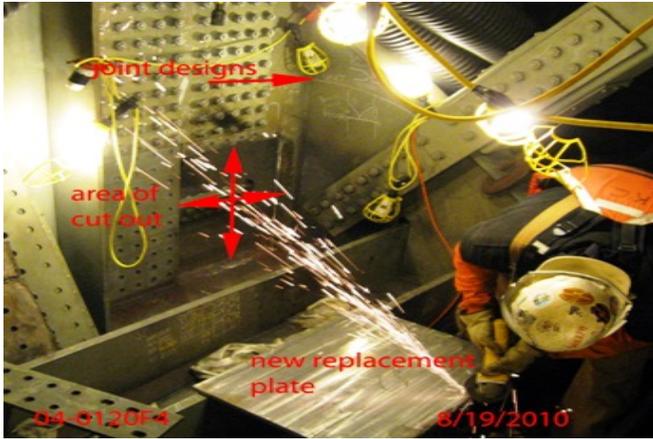
Adjacent to the weld joints at W1/W2 work was in progress on a cut out section of the longitudinal diaphragm on the outboard W2 side of the weld joint. See photo below for details. This QA Inspector observed ABF welding personnel Fred Kaddu (#2188) was in the process of laying out a section of plate material to be fit and welded at this location. This QA Inspector observed an oxygen acetylene torch was used for cutting and a grinder used to clean and shape the outside edges. This QA Inspector observed QC Inspector Mike Johnson arrived at this location and was informed of the following: A smaller section had been previously cut out and welded, inspected and rejected by QC after the UT inspection. The section cut out today was larger than the original cut out, therefore removing the rejected Complete Joint Penetration (CJP) welds previously rejected by QC personnel. This QA Inspector observed the plate did not have any identifying markings such as a heat number from a Material Test Report (MTR) and brought to the attention of QC Inspector Mike Johnson. QC Inspector Mike Johnson informed this QA Inspector Jim Bowers, ABF Quality Control Manager (QCM), had a package with the documentation. Later in the shift this QA Inspector discovered the material had been tagged to the jobsite and all documentation had been reviewed. This QA Inspector was also informed by QC Inspector Mike Johnson the proposed joint designs were a double vee groove butt joint for the one vertical section of welding, a double bevel groove butt joint for the one horizontal section of welding and that the bottom section was fillet welded. The cut out section and plate to be fit up were a work in progress during this QA Inspector's shift, but the work observed appeared to follow industry standards and that it could meet the contract requirements.
