**DEPARTMENT OF TRANSPORTATION**

Contract #: 04-0120F4Cty: SF/ALA Rte: 80 PM: 13.2/13.9File #: 69.28**WELDING INSPECTION REPORT****Resident Engineer:** Pursell, Gary**Address:** 333 Burma Road**City:** Oakland, CA 94607**Report No:** WIR-016386**Date Inspected:** 23-Aug-2010**Project Name:** SAS Superstructure**OSM Arrival Time:** 700**Prime Contractor:** American Bridge/Fluor Enterprises, a JV**OSM Departure Time:** 1900**Contractor:** Zhenhua Port Machinery Company, Ltd (ZPMC), Changxing Island **Location:** Shanghai, China**CWI Name:** Li Yang**CWI Present:** Yes No**Inspected CWI report:** Yes No N/A**Rod Oven in Use:** Yes No N/A**Electrode to specification:** Yes No N/A**Weld Procedures Followed:** Yes No N/A**Qualified Welders:** Yes No N/A**Verified Joint Fit-up:** Yes No N/A**Approved Drawings:** Yes No N/A**Approved WPS:** Yes No N/A**Delayed / Cancelled:** Yes No N/A**Bridge No:** 34-0006**Component:** OBG Segment**Summary of Items Observed:**

Segment 10AW/10BW

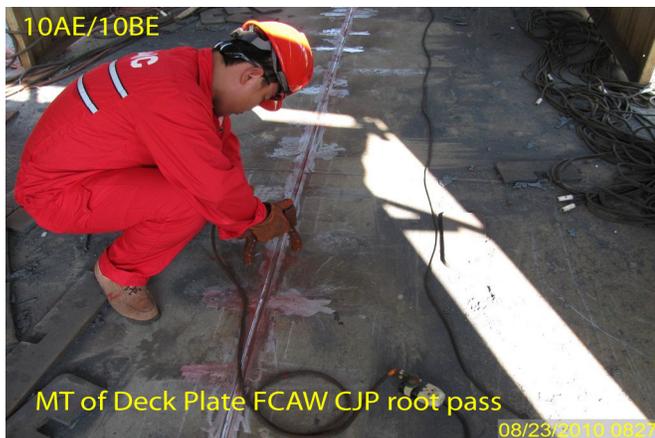
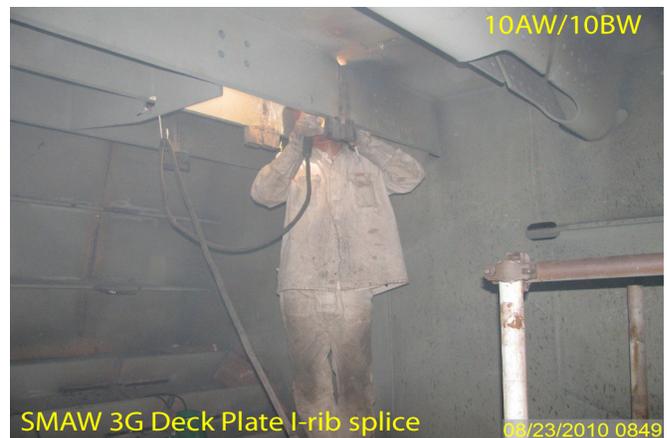
Unless otherwise noted, all work observed on this date appeared to generally comply with applicable contract documents.
