DEPARTMENT OF TRANSPORTATION

Contract #: 04-0120F4Cty: SF/ALA Rte: 80 PM: 13.2/13.9File #: 69.28**WELDING INSPECTION REPORT****Resident Engineer:** Pursell, Gary**Address:** 333 Burma Road**City:** Oakland, CA 94607**Report No:** WIR-016388**Date Inspected:** 19-Aug-2010**Project Name:** SAS Superstructure**OSM Arrival Time:** 1900**Prime Contractor:** American Bridge/Fluor Enterprises, a JV**OSM Departure Time:** 700**Contractor:** Zhenhua Port Machinery Company, Ltd (ZPMC), Changxing Island **Location:** Shanghai, China**CWI Name:** See Below**CWI Present:** Yes No**Inspected CWI report:** Yes No N/A**Rod Oven in Use:** Yes No N/A**Electrode to specification:** Yes No N/A**Weld Procedures Followed:** Yes No N/A**Qualified Welders:** Yes No N/A**Verified Joint Fit-up:** Yes No N/A**Approved Drawings:** Yes No N/A**Approved WPS:** Yes No N/A**Delayed / Cancelled:** Yes No N/A**Bridge No:** 34-0006**Component:** OBG**Summary of Items Observed:**

OBG Segment Trial Assembly

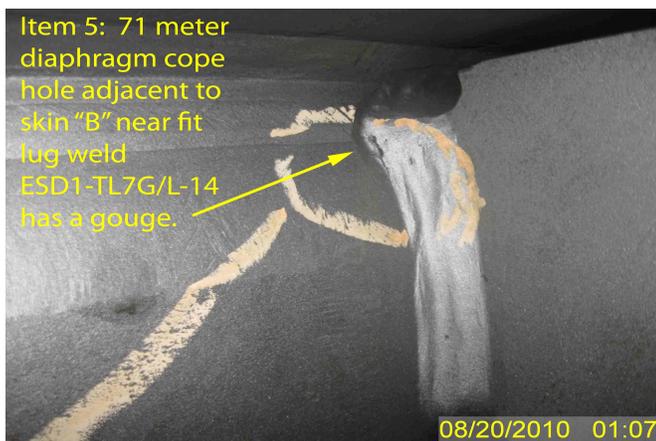
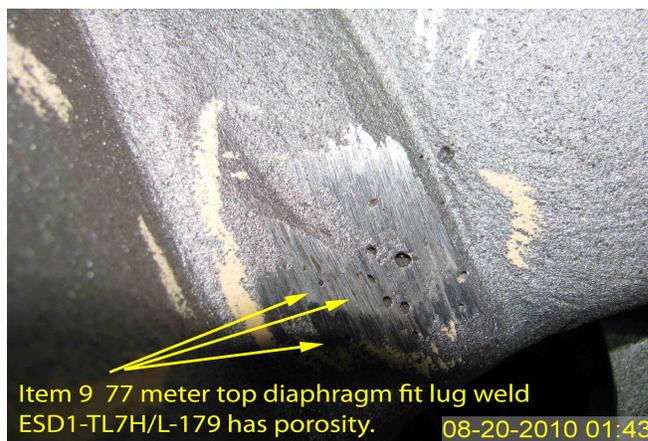
ZPMC requested Caltrans personnel to perform visual inspections of East Tower Lift 2 between the 65M upper double diaphragm to 83 meter elevation on August 20, 2010 at around 00:30 hours following the initial pre-blast cleaning of the steel surfaces. Caltrans QA Inspectors Ken Riley, Mike Hasler and this QA Inspector performed random visual inspections of these areas. This QA Inspector visually observed approximately 30 locations that required grinding to resolve visual weld spatter, arc strikes, shallow nicks, scrapes, and other minor surface rejections and three locations which require weld repairs. ABF and ZPMC Inspectors also performed visual inspections of the areas indicated above and a total of thirteen areas were identified as needing weld repairs. A "Blast Inspection" incident report has been issued to document these repairs and below is a total list of the weld repairs that were observed by all Inspectors.

1- 65 meter diaphragm weld ESD1-TL7F/L-18 to skin "B" has porosity.

- 2- 68 meter diaphragm fit lug weld ESD1-TL7F/L-146 to diaphragm plate has porosity.
 - 3- 68 meter diaphragm fit lug weld ESD1-TL7F/L-147 to diaphragm plate has porosity.

- 4- 71 meter diaphragm cope hole has weld overlap opposite of fit lug weld ESD1-TL7G/L-18.
 - 5- 71 meter diaphragm cope hole adjacent to skin "B" near fit lug weld ESD1-TL7G/L-14 has a gouge.

- 6- 77 meter bottom diaphragm has a base metal gouge at weld ESD1-TL7H/L-19.
 - 7- 77 meter top diaphragm fit lug weld ESD1-TL7H/L-169 has porosity.
 - 8- 77 meter top diaphragm fit lug weld ESD1-TL7H/L-174 has porosity.

- 9- 77 meter top diaphragm fit lug weld ESD1-TL7H/L-179 has porosity.
 - 10- 77 meter top diaphragm has underfill at fit lug weld ESD1-TL7H/L-110.
 - 11- Skin "D" has a gouge in the base material 1800 mm above 80.75 meter diaphragm, (400 mm from shaft top end).

- 12- 80.75 meter diaphragm to skin plate "E" weld ESD1-TL7H/L-36 has porosity.
 - 13- Skin "A" to skin plate "B" corner weld has porosity 190 mm from the 83 meter top end of the shaft.
