DEPARTMENT OF TRANSPORTATION

Contract #: 04-0120F4Cty: SF/ALA Rte: 80 PM: 13.2/13.9File #: 69.28**WELDING INSPECTION REPORT****Resident Engineer:** Pursell, Gary**Address:** 333 Burma Road**City:** Oakland, CA 94607**Report No:** WIR-016390**Date Inspected:** 21-Aug-2010**Project Name:** SAS Superstructure**OSM Arrival Time:** 1900**Prime Contractor:** American Bridge/Fluor Enterprises, a JV**OSM Departure Time:** 700**Contractor:** Zhenhua Port Machinery Company, Ltd (ZPMC), Changxing Island **Location:** Shanghai, China**CWI Name:** See Below**CWI Present:** Yes No**Inspected CWI report:** Yes No N/A**Rod Oven in Use:** Yes No N/A**Electrode to specification:** Yes No N/A**Weld Procedures Followed:** Yes No N/A**Qualified Welders:** Yes No N/A**Verified Joint Fit-up:** Yes No N/A**Approved Drawings:** Yes No N/A**Approved WPS:** Yes No N/A**Delayed / Cancelled:** Yes No N/A**Bridge No:** 34-0006**Component:** OBG**Summary of Items Observed:**

OBG Segment Trial Assembly

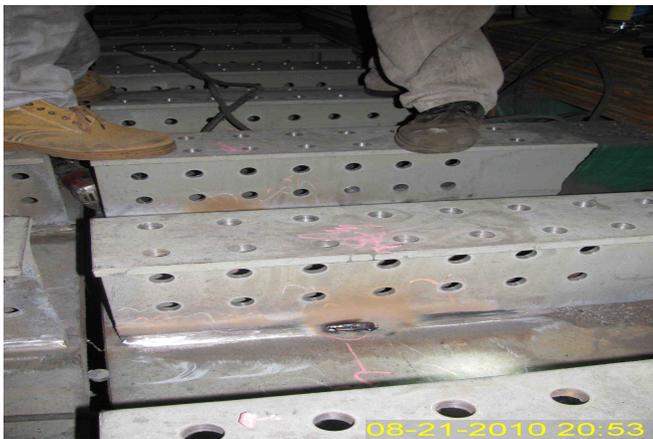
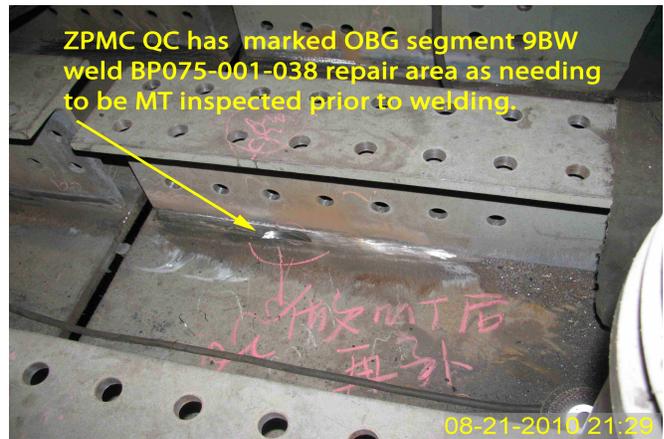
This QA Inspector observed ZPMC welder Mr. Zhang Feng, stencil 049769 used shielded metal arc welding process to perform a repair of bottom plate hold back weld BP075-001-038. This hold back weld appears to have had a magnetic particle (MT) rejection and part of the weld had been ground out to remove the MT indication. This QA Inspector did not observe any acetylene torch, electric heaters or other equipment near where this weld had been made and the base material adjacent to the weld repair did not appear to have been preheated prior to welding. This QA Inspector informed ZPMC CWI Mr. Shi Lei that Mr. Zhang Feng appears to have made this weld without any preheating of the base material. Mr. Shi Lei informed this QA Inspector that the weld material would be ground out and the ground area will be MT inspected prior to welding. Mr. Shi Lei marked on the steel that an MT inspection will be required prior to welding and he said there are no ZPMC MT inspectors available at this time to perform the inspections and the MT inspection of the weld removal area will be performed tomorrow. This weld was located on the bottom plate of OBG segment 10AE adjacent to OBG segment 10BE. Items observed on this date do not appear fully comply with applicable contract documents. See the photographs below for additional information.
