**DEPARTMENT OF TRANSPORTATION**

Contract #: 04-0120F4Cty: SF/ALA Rte: 80 PM: 13.2/13.9File #: 1.28**WELDING INSPECTION REPORT****Resident Engineer:** Pursell, Gary**Address:** 333 Burma Road**City:** Oakland, CA 94607**Report No:** WIR-016439**Date Inspected:** 24-Aug-2010**Project Name:** SAS Superstructure**OSM Arrival Time:** 700**Prime Contractor:** American Bridge/Fluor Enterprises, a JV**OSM Departure Time:** 1530**Contractor:** American Bridge/Fluor Enterprises, a JV**Location:** Jobsite**CWI Name:** See below**CWI Present:** Yes No**Inspected CWI report:** Yes No N/A**Rod Oven in Use:** Yes No N/A**Electrode to specification:** Yes No N/A**Weld Procedures Followed:** Yes No N/A**Qualified Welders:** Yes No N/A**Verified Joint Fit-up:** Yes No N/A**Approved Drawings:** Yes No N/A**Approved WPS:** Yes No N/A**Delayed / Cancelled:** Yes No N/A**Bridge No:** 34-0006**Component:** SAS OBG**Summary of Items Observed:**

## WELDING INSPECTION REPORT

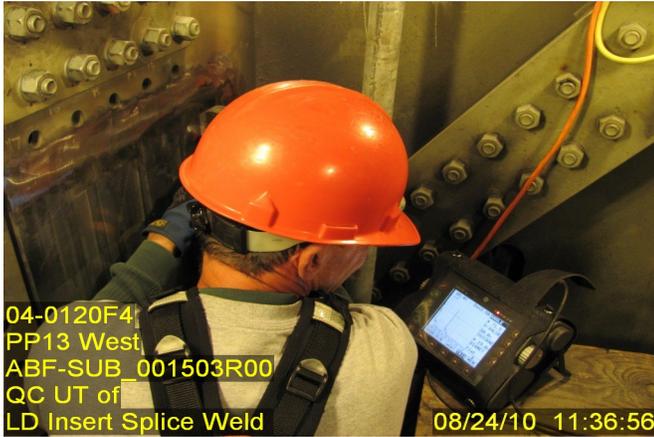
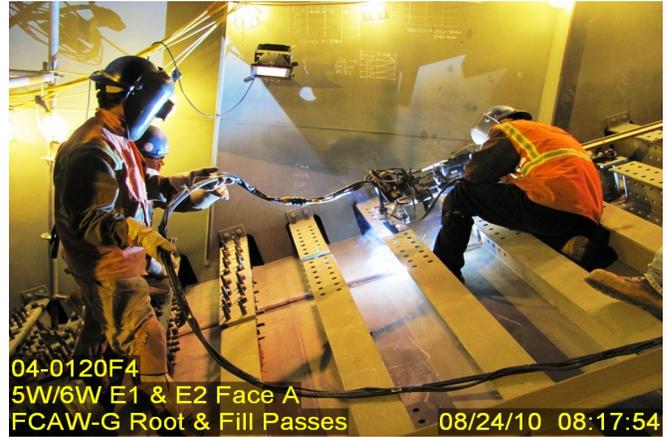
6). OBG Field Splice 5W/6W Weld ID: E1 & E2, Face A

The QAI periodically observed AB/F approved welder Song Tao Huang (ID 3794) performing welding per the Flux Cored Arc Welding (FCAW-G) process in the 3G (vertical) position of root and fill passes on weld ID: E1 & E2. See photo below. The QAI observed QC Inspector Tony Sherwood was present to monitor the progress and verify that the welding parameters were within the limits established by the approved Welding Procedure Specification (WPS) identified as ABF-WPS-D1.5-3042B-1. The QAI observed that the work at this location was in process for the duration of the shift and appeared to be in general compliance with contract documents.
