DEPARTMENT OF TRANSPORTATION

Contract #: 04-0120F4Cty: SF/ALA Rte: 80 PM: 13.2/13.9File #: 99.28**WELDING INSPECTION REPORT****Resident Engineer:** Pursell, Gary**Address:** 333 Burma Road**City:** Oakland, CA 94607**Report No:** WIR-016452**Date Inspected:** 23-Aug-2010**Project Name:** SAS Superstructure**OSM Arrival Time:** 700**Prime Contractor:** American Bridge/Fluor Enterprises, a JV**OSM Departure Time:** 1900**Contractor:** Zhenhua Port Machinery Company, Ltd (ZPMC)**Location:** Shanghai, China**CWI Name:** Zhu Zhong Hai**CWI Present:** Yes No**Inspected CWI report:** Yes No N/A**Rod Oven in Use:** Yes No N/A**Electrode to specification:** Yes No N/A**Weld Procedures Followed:** Yes No N/A**Qualified Welders:** Yes No N/A**Verified Joint Fit-up:** Yes No N/A**Approved Drawings:** Yes No N/A**Approved WPS:** Yes No N/A**Delayed / Cancelled:** Yes No N/A**Bridge No:** 34-0006**Component:** OBG Trial Assembly**Summary of Items Observed:**

Orthotropic Box Girder (OBG) at Trial Assembly Areas

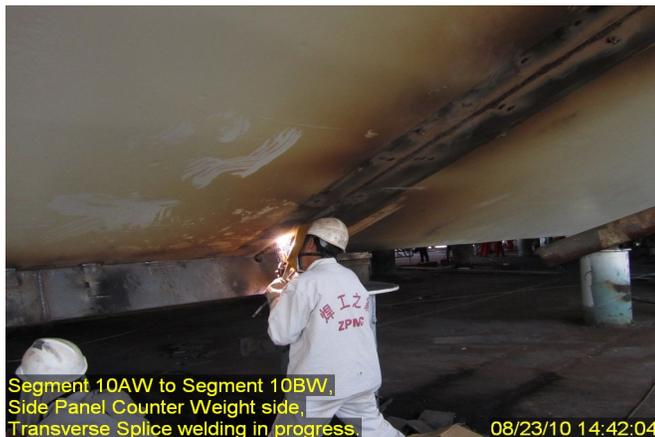
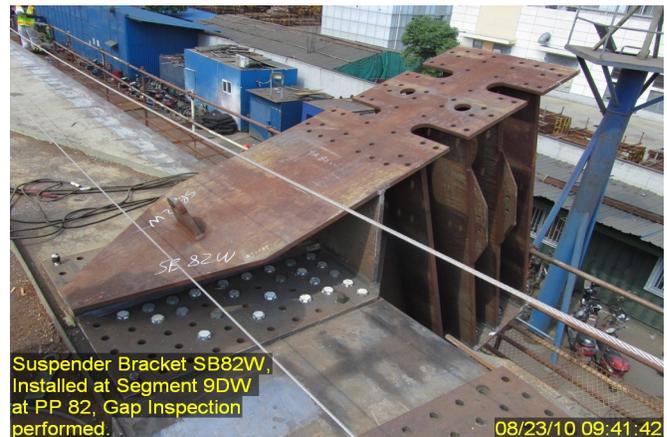
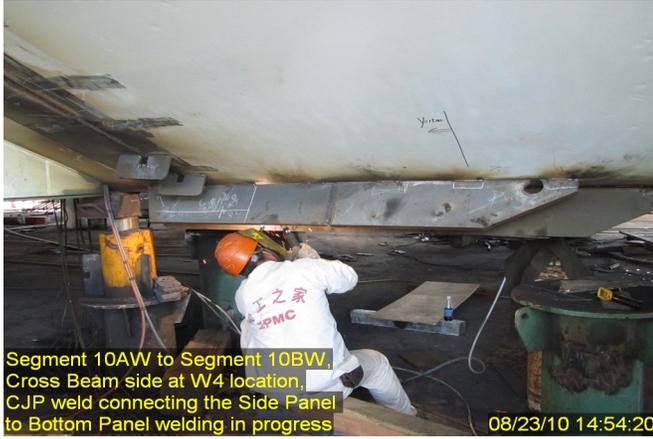
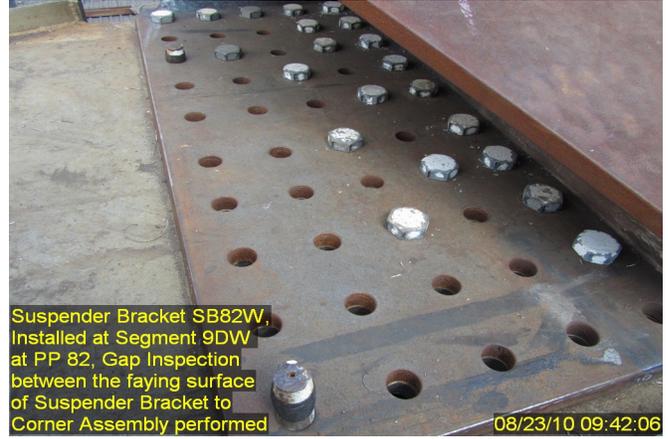
This Quality Assurance (QA) Inspector verified and measured the gap between the faying surfaces of Deck Panel Corner Assembly to Suspender Bracket (SB) flange at the pre-installation stage along with ZPMC QC Inspector Mr. Shen Jian Bo and observed the gap to be in general compliance with contact requirements. Inspection was performed against the Notification No. 00015 Dated August 23, 2010.

SB82W installed at Segment 9DW at PP 82, Counter Weight side.

This QA Inspector observed the in-process welding by Shielded Metal Arc Welding (SMAW) process on a Complete Joint Penetration (CJP) groove weld. The Weld joint was designated as Seg059A-019. The welder identification was 067829 and was observed welding in the 4G (Overhead) position using approved Welding Procedure Specification WPS-B-P-2214-Tc-U4b-FCM-1. The piece mark was identified as the Bottom Panel to Side Panel hold back area at Work Point W4. Please reference the pictures attached for more comprehensive details.

identification was 067829 and was observed welding in the 4G (Overhead) position using approved Welding Procedure Specification WPS-B-P-2214-Tc-U4b-FCM-1. The piece mark was identified as the Bottom Panel to Side Panel hold back area at Work Point W4. Please reference the pictures attached for more comprehensive details.

This QA Inspector observed the in-process welding by Shielded Metal Arc Welding (SMAW) process on a Complete Joint Penetration (CJP) groove weld. The Weld joint was designated as OBW10B-002. The welder identification was 067589 and was observed welding in the 4G (Overhead) position using approved Welding Procedure Specification WPS-B-P-2214-B-U2-FCM-1. The piece mark was identified as the Side Panel, transverse splice weld at Counter Weight side. Please reference the pictures attached for more comprehensive details.
