**DEPARTMENT OF TRANSPORTATION**

Contract #: 04-0120F4Cty: SF/ALA Rte: 80 PM: 13.2/13.9File #: 99.28**WELDING INSPECTION REPORT****Resident Engineer:** Pursell, Gary**Address:** 333 Burma Road**City:** Oakland, CA 94607**Report No:** WIR-016484**Date Inspected:** 22-Aug-2010**Project Name:** SAS Superstructure**OSM Arrival Time:** 700**Prime Contractor:** American Bridge/Fluor Enterprises, a JV**OSM Departure Time:** 1900**Contractor:** Zhenhua Port Machinery Company, Ltd (ZPMC) Chanxing Island**Location:** Shanghai, China**CWI Name:** Mr. Geng Wei and Mr. Xu Tao**CWI Present:** Yes No**Inspected CWI report:** Yes No N/A**Rod Oven in Use:** Yes No N/A**Electrode to specification:** Yes No N/A**Weld Procedures Followed:** Yes No N/A**Qualified Welders:** Yes No N/A**Verified Joint Fit-up:** Yes No N/A**Approved Drawings:** Yes No N/A**Approved WPS:** Yes No N/A**Delayed / Cancelled:** Yes No N/A**Bridge No:** 34-0006**Component:** OBG Segments**Summary of Items Observed:**

## WELDING INSPECTION REPORT

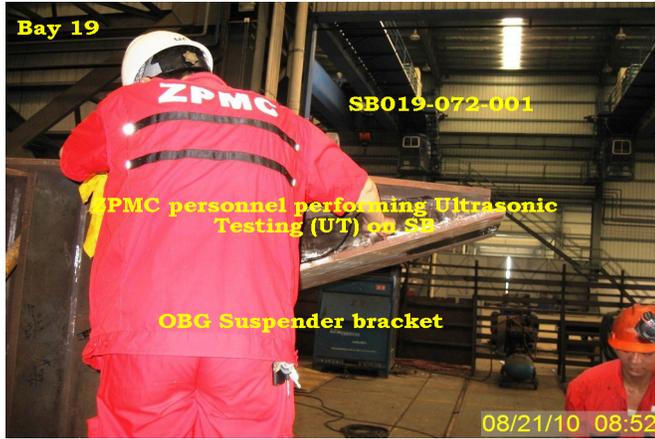
Visual Inspection Details: During random Quality Assurance Visual review of cope holes located on OBG Suspender bracket at bay 19, this Quality Assurance Inspector (QA) discovered 4 mm porosity on inside of cope hole; the weld joint number is identified as SB020-084-067 and suspender bracket is identified as 84E. The weld repair area is clearly marked on the material near the holes. The suspender bracket is identified as SPCM. See the attached pictures
