DEPARTMENT OF TRANSPORTATION

Quality Assurance and Source Inspection

Contract #: 04-0120F4Cty: SF/ALA Rte: 80 PM: 13.2/13.9File #: 69.28**WELDING INSPECTION REPORT****Resident Engineer:** Pursell, Gary**Address:** 333 Burma Road**City:** Oakland, CA 94607**Report No:** WIR-016505**Date Inspected:** 26-Aug-2010**Project Name:** SAS Superstructure**OSM Arrival Time:** 700**Prime Contractor:** American Bridge/Fluor Enterprises, a JV**OSM Departure Time:** 1900**Contractor:** Zhenhua Port Machinery Company, Ltd (ZPMC), Changxing Island **Location:** Shanghai, China**CWI Name:** Mr. Zhao Chen Sun**CWI Present:** Yes No**Inspected CWI report:** Yes No N/A**Rod Oven in Use:** Yes No N/A**Electrode to specification:** Yes No N/A**Weld Procedures Followed:** Yes No N/A**Qualified Welders:** Yes No N/A**Verified Joint Fit-up:** Yes No N/A**Approved Drawings:** Yes No N/A**Approved WPS:** Yes No N/A**Delayed / Cancelled:** Yes No N/A**Bridge No:** 34-0006**Component:** Tower**Summary of Items Observed:**

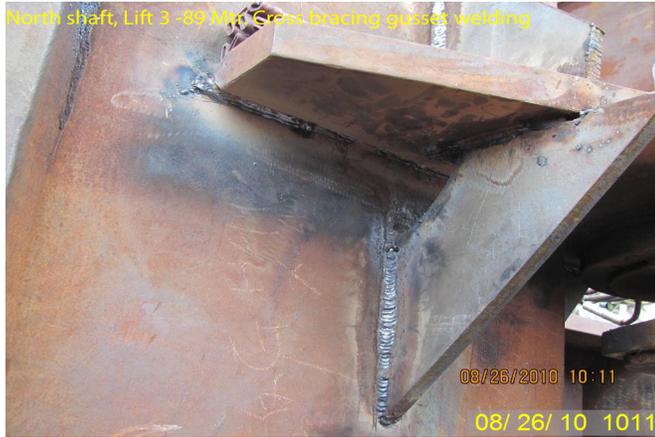
1. This QA inspector, Baskar Govindarajan, observed, ZPMC qualified welding personnel identified as 040365 perform SMAW welding on; Cross Bracing Gusset and Skin E of North shaft, Lift 3, in 89 mtr. elevation and the weld joint is identified as WD1-GUSA3-3-89 mtr.-N-4B. ZPMC CWI Identified as Mr. Zhao Chen Sun. The welding parameters as measured using QC's calibrated instruments appeared to be in general compliance with WPS-B-P-2214-TC-U5B-FCM. (Photo attached)

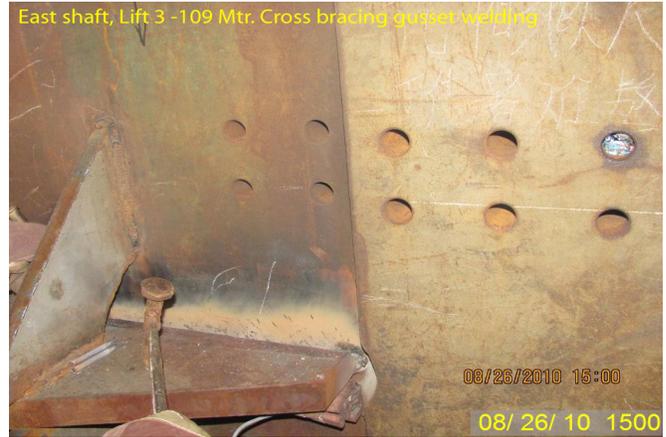
3. This QA inspector, Baskar Govindarajan, observed, ZPMC qualified welding personnel identified as 040690 perform SMAW welding on; Cross Bracing Gusset and Skin E of East shaft, Lift 3, in 109 mtr. elevation and the weld joint is identified as WD1-GUSA3-3-109 mtr.-E-4A. ZPMC CWI Identified as Mr. Zhao Chen Sun. The welding parameters as measured using QC's calibrated instruments appeared to be in general compliance with

WPS-B-P-2212-TC-U5B-FCM. (Photo attached)
