DEPARTMENT OF TRANSPORTATION

Contract #: 04-0120F4Cty: SF/ALA Rte: 80 PM: 13.2/13.9File #: 69.28**WELDING INSPECTION REPORT****Resident Engineer:** Pursell, Gary**Address:** 333 Burma Road**City:** Oakland, CA 94607**Report No:** WIR-016506**Date Inspected:** 18-Aug-2010**Project Name:** SAS Superstructure**OSM Arrival Time:** 700**Prime Contractor:** American Bridge/Fluor Enterprises, a JV**OSM Departure Time:** 1900**Contractor:** Zhenhua Port Machinery Company, Ltd (ZPMC), Changxing Island **Location:** Shanghai, China**CWI Name:** Qiu Wen**CWI Present:** Yes No**Inspected CWI report:** Yes No N/A**Rod Oven in Use:** Yes No N/A**Electrode to specification:** Yes No N/A**Weld Procedures Followed:** Yes No N/A**Qualified Welders:** Yes No N/A**Verified Joint Fit-up:** Yes No N/A**Approved Drawings:** Yes No N/A**Approved WPS:** Yes No N/A**Delayed / Cancelled:** Yes No N/A**Bridge No:** 34-0006**Component:** Tower & OBG Components**Summary of Items Observed:**

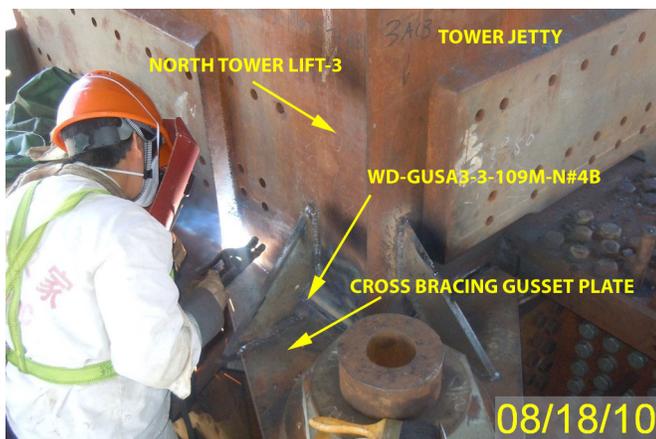
Weld joint # 4B located on North tower Lift-3 cross bracing gusset plate to doubler strut plate WD – GUSA3 – 3 – 109M – N. Welder is identified as 040365. ZPMC Quality Control (QC) Inspector is identified Fu Wei Min. The welding variables recorded by QC appeared to comply with the WPS – B – P – 2214 – Tc – U5b – FCM. (See attached photo)

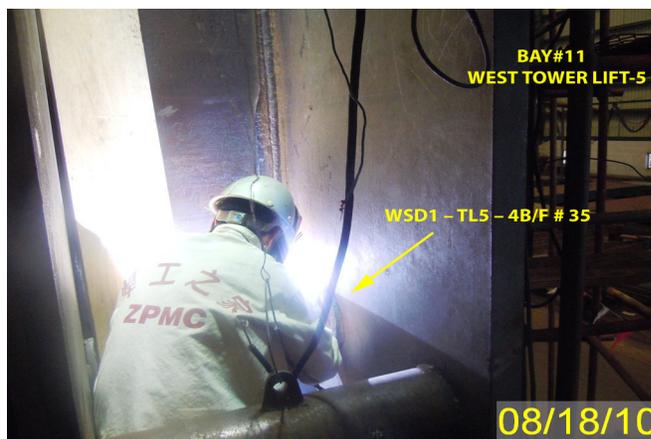
Weld joint # 35 located on West tower Lift-5 Grillage Assembly WSD1 – TL5 – 4B/F. Welder is identified as 037997. ZPMC Quality Control (QC) Inspector is identified as Xu Jie. The welding variables recorded by QC appeared to comply with the WPS – B – T – 3213 – TC – U4c.
