DEPARTMENT OF TRANSPORTATION

Contract #: 04-0120F4Cty: SF/ALA Rte: 80 PM: 13.2/13.9File #: 69.28**WELDING INSPECTION REPORT****Resident Engineer:** Siegenthaler, Peter**Address:** 333 Burma Road**City:** Oakland, CA 94607**Report No:** WIR-016515**Date Inspected:** 24-Aug-2010**Project Name:** SAS Superstructure**OSM Arrival Time:** 700**Prime Contractor:** American Bridge/Fluor Enterprises, a JV**OSM Departure Time:** 1900**Contractor:** Zhenhua Port Machinery Company, Ltd (ZPMC), Changxing Island **Location:** Shanghai, China

Bridge No: 34-0006**Component:** Tower & OBG Components**Summary of Items Observed:**

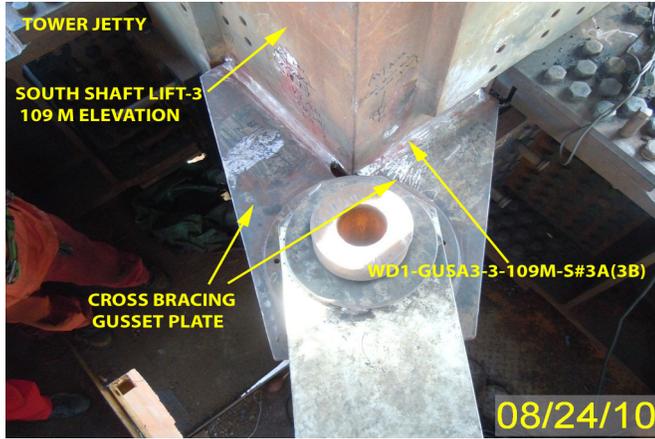
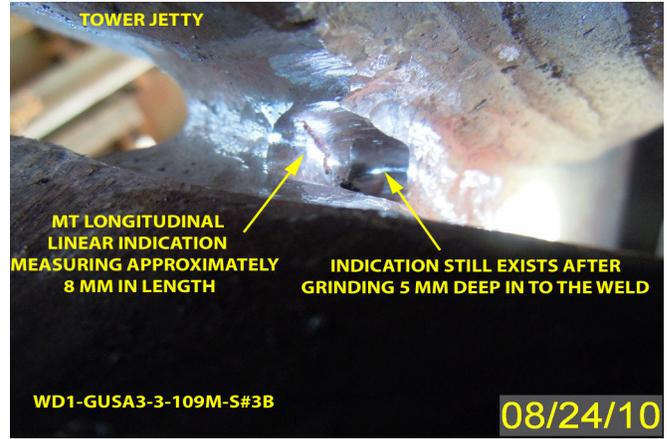
During Magnetic Particle Testing (MT) review of welds on Cross Bracing Gusset Plate, 109 M elevation South Tower Lift-3, this Quality Assurance Inspector (QA) discovered the following issue:

- One (1) longitudinal indication measuring approximately 8 mm in length.
- The member is identified as Cross Bracing Gusset Plate.
- The weld is identified as WD1 – GUSA3 – 3 – 109M – S # 3B.
- The weld is a Complete Joint Penetration (CJP) T-joint joining the Cross Bracing Gusset Plate to South Tower Lift-3 at 109 M elevation.
- The member is Seismic Performance critical Member (SPCM).
- The member is located in TOWER JETTY.

The Notice of Witness Inspection Number (NWIT) is 006469. The indication is located inside the area that has been previously tested and accepted by ZPMC Quality Control (QC) personnel. As per the contract documents, ZPMC's QC personnel are required to perform 100% MT inspection of these welds.

AWS D1.5 (02) Section 6.26.2 – “Welds that are subject to MT in addition to visual inspection shall have no cracks.
