DEPARTMENT OF TRANSPORTATION

Contract #: 04-0120F4Cty: SF/ALA Rte: 80 PM: 13.2/13.9File #: 1.28**WELDING INSPECTION REPORT****Resident Engineer:** Pursell, Gary**Address:** 333 Burma Road**City:** Oakland, CA 94607**Report No:** WIR-016543**Date Inspected:** 26-Aug-2010**Project Name:** SAS Superstructure**OSM Arrival Time:** 1000**Prime Contractor:** American Bridge/Fluor Enterprises, a JV**OSM Departure Time:** 1830**Contractor:** American Bridge/Fluor Enterprises, a JV**Location:** Job Site

WELDING INSPECTION REPORT

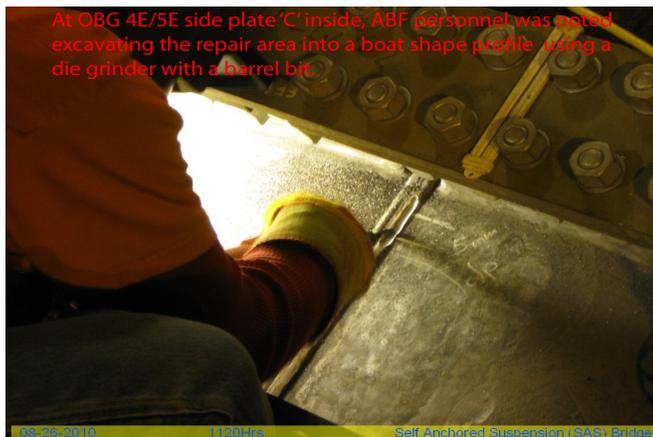
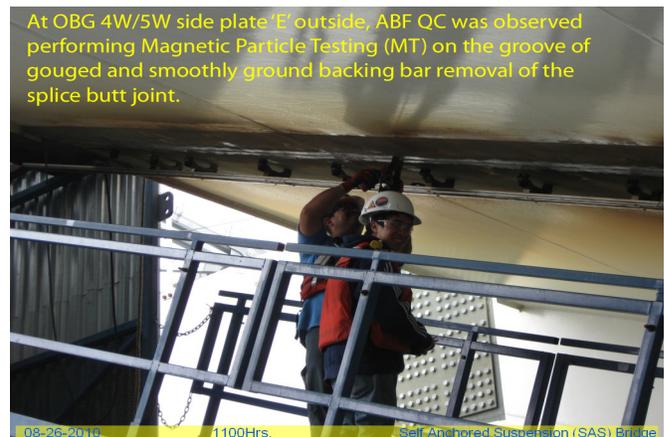
At OBG 4E/5E side plate 'C' inside, QA randomly observed ABF/JV qualified welder Fred Kaddu perform CJP groove welding repair. The welder was observed welding in the 3G (vertical) position utilizing Shielded Metal Arc Welding (SMAW) with 1/8" diameter E7018H4R electrode implementing welding procedure ABF-WPS-D15-1000-Repairs. The weld repairs were excavated to a boat shape. The repair excavations were preheated to more than 140 degree Fahrenheit using propane gas torch prior welding. During the shift, ABF QC Jesse Cayabyab was noted monitoring the welder. Prior welding, ABF QC Jesse Cayabyab was also observed performing Magnetic Particle Testing (MT) on the repair excavations. During the shift, the welder has completed four welding repairs inside and welding was still continuing.

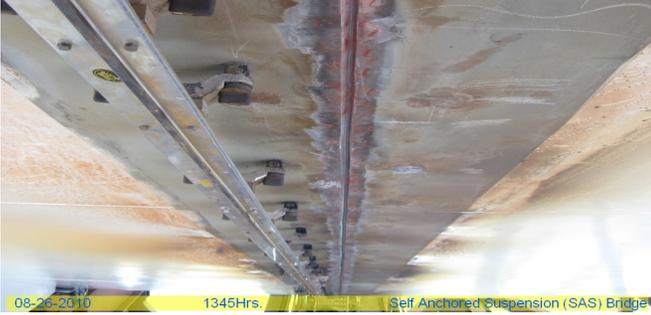
At DBG 4W/5W side plate 'E' outside, the groove of the gouged and ground backing bar removal was smooth and has a width of 25mm to 30mm and a depth of 10mm. After the satisfactory completion of the Magnetic Particle Testing (MT), the joint is now ready for the splice back welding.

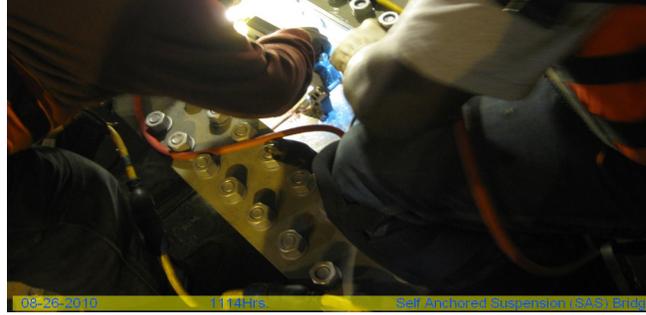
At DBG 4E/5E side plate 'C' inside, ABF QC Jesse Cayabyab was observed performing Magnetic Particle Testing (MT) on the excavation of the (UT) repair of the welded splice joint. The QC was using electromagnetic yoke with red magnetic powder as detecting media.
