DEPARTMENT OF TRANSPORTATION

Contract #: 04-0120F4Cty: SF/ALA Rte: 80 PM: 13.2/13.9File #: 1.28**WELDING INSPECTION REPORT****Resident Engineer:** Pursell, Gary**Address:** 333 Burma Road**City:** Oakland, CA 94607**Report No:** WIR-016546**Date Inspected:** 26-Aug-2010**Project Name:** SAS Superstructure**OSM Arrival Time:** 700**Prime Contractor:** American Bridge/Fluor Enterprises, a JV**OSM Departure Time:** 1530**Contractor:** American Bridge/Fluor Enterprises, a JV**Location:** Jobsite**CWI Name:** See below**CWI Present:** Yes No**Inspected CWI report:** Yes No N/A**Rod Oven in Use:** Yes No N/A**Electrode to specification:** Yes No N/A**Weld Procedures Followed:** Yes No N/A**Qualified Welders:** Yes No N/A**Verified Joint Fit-up:** Yes No N/A**Approved Drawings:** Yes No N/A**Approved WPS:** Yes No N/A**Delayed / Cancelled:** Yes No N/A**Bridge No:** 34-0006**Component:** SAS OBG**Summary of Items Observed:**

- 1). OBG Fillet Welding 2W/3W Weld ID: Drip Edge
- 2). OBG Field Splice 4W/5W Weld ID: E1 & E2, Face B - (Grinding)
- 3). OBG Field Splice 5W/6W Weld ID: E1 & E2, Face A - (FCAW-G in process)
- 4). OBG Field Splice 5E/6E Weld ID: B1, Face B - (QAI Verification)

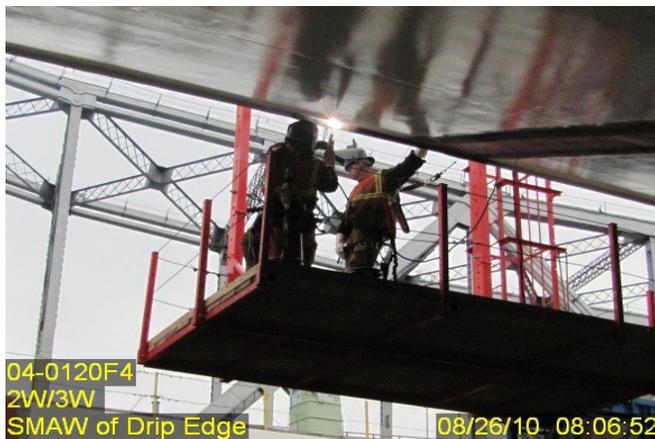
- 1). OBG Fillet Welding 2W/3W Weld ID: Drip Edge

The QAI periodically observed AB/F approved welder Rick Clayborn (ID 2773) performing fillet welding and partial penetration welding per the Shielded Metal Arc Welding (SMAW) process in the 4F (overhead) and 3F (vertical) positions to install drip edge pieces. See photo below. QC Inspector Jim Cunningham was periodically present to monitor the progress and verify that the welding parameters were within the limits established by the approved welding Procedure Specification (WPS) identified as ABF-WPS-D1.5-F1202 & ABF-WPS-D1.5-1030. The QAI observed that the work appeared to be in general compliance with contract documents.
