**DEPARTMENT OF TRANSPORTATION**

Contract #: 04-0120F4Cty: SF/ALA Rte: 80 PM: 13.2/13.9File #: 69.28**WELDING INSPECTION REPORT****Resident Engineer:** Siegenthaler, Peter**Address:** 333 Burma Road**City:** Oakland, CA 94607**Report No:** WIR-016554**Date Inspected:** 02-Sep-2010**Project Name:** SAS Superstructure**OSM Arrival Time:** 700**Prime Contractor:** American Bridge/Fluor Enterprises, a JV**OSM Departure Time:** 1700**Contractor:** Zhenhua Port Machinery Company, Ltd (ZPMC), Changxing Island **Location:** Shanghai, China**CWI Name:** Li Yang**CWI Present:** Yes No**Inspected CWI report:** Yes No N/A**Rod Oven in Use:** Yes No N/A**Electrode to specification:** Yes No N/A**Weld Procedures Followed:** Yes No N/A**Qualified Welders:** Yes No N/A**Verified Joint Fit-up:** Yes No N/A**Approved Drawings:** Yes No N/A**Approved WPS:** Yes No N/A**Delayed / Cancelled:** Yes No N/A**Bridge No:** 34-0006**Component:** OBG Segment**Summary of Items Observed:**

On this date Caltrans OSM Quality Assurance (QA) Inspector, Dan Hernandez was present during the times noted above to observe the fit up, welding and related activities associated with the fabrication of the San Francisco O

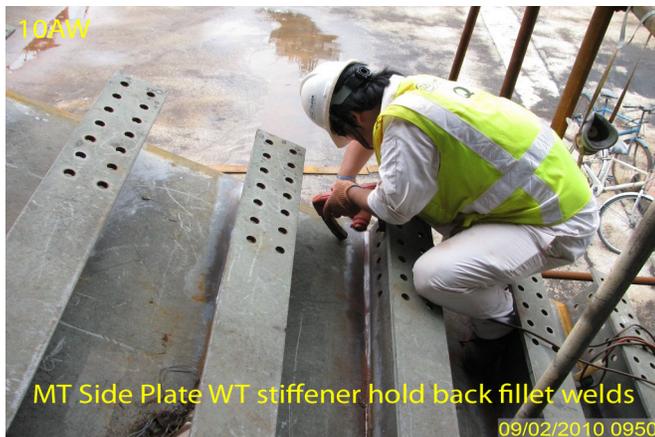
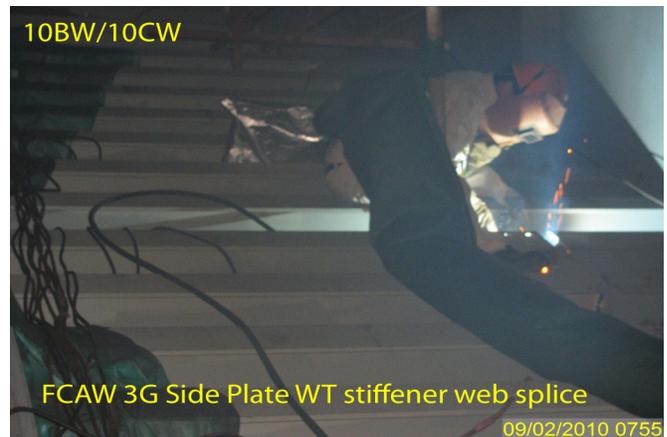
Unless otherwise noted, all work observed on this date appeared to generally comply with applicable contract documents.
