**DEPARTMENT OF TRANSPORTATION**

Contract #: 04-0120F4Cty: SF/ALA Rte: 80 PM: 13.2/13.9File #: 99.28**WELDING INSPECTION REPORT****Resident Engineer:** Siegenthaler, Peter**Address:** 333 Burma Road**City:** Oakland, CA 94607**Report No:** WIR-016566**Date Inspected:** 03-Sep-2010**Project Name:** SAS Superstructure**OSM Arrival Time:** 700**Prime Contractor:** American Bridge/Fluor Enterprises, a JV**OSM Departure Time:** 1900**Contractor:** Zhenhua Port Machinery Company, Ltd (ZPMC)**Location:** Shanghai, China

Orthotropic Box Girder (OBG) at Trial Assembly Areas

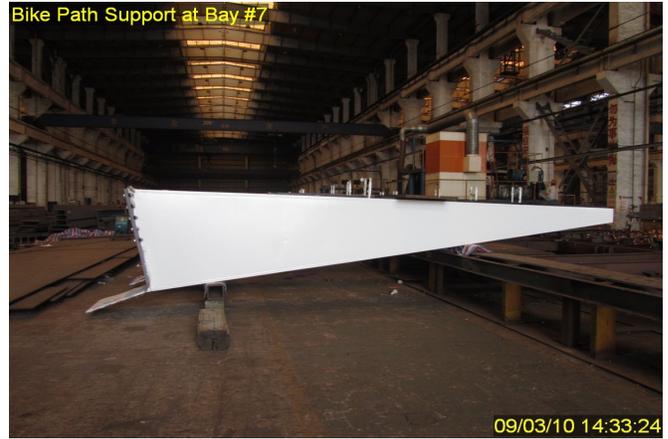
This QA Inspector performed Dimension Inspection to check and measure various items of the Bike Path support at Bay # 7 and the following items was inspected.

Bike Path type identified as BK1A.

1. Overall length of support (end of cantilever to edge panel contact flange) at east and west side.
2. Distance from end of cantilever to nearest anchor bolt at east and west side.
3. Longitudinal center to center spacing between anchor bolts at east and west side
4. Transverse center to center spacing between anchor bolts at east and west side.
