DEPARTMENT OF TRANSPORTATION

Contract #: 04-0120F4Cty: SF/ALA Rte: 80 PM: 13.2/13.9File #: 99.28**WELDING INSPECTION REPORT****Resident Engineer:** Siegenthaler, Peter**Address:** 333 Burma Road**City:** Oakland, CA 94607**Report No:** WIR-016576**Date Inspected:** 05-Sep-2010**Project Name:** SAS Superstructure**OSM Arrival Time:** 700**Prime Contractor:** American Bridge/Fluor Enterprises, a JV**OSM Departure Time:** 1900**Contractor:** Zhenhua Port Machinery Company, Ltd (ZPMC)**Location:** Shanghai, China

Orthotropic Box Girder (OBG) at Trial Assembly Areas

Incident Report generated at Lift 9 (Segment 9AE, 9BE, 9CE, 9DE and 9EE)

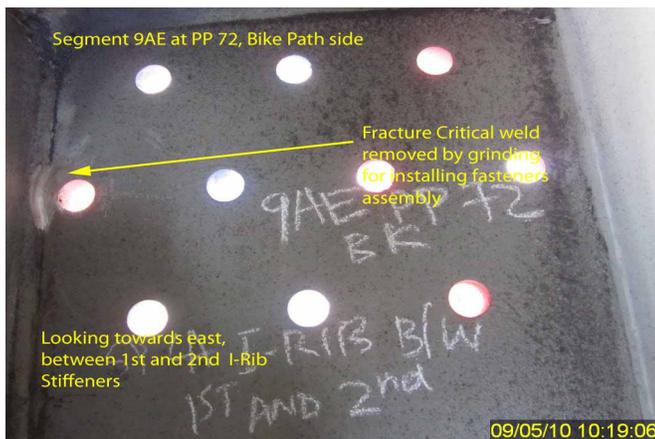
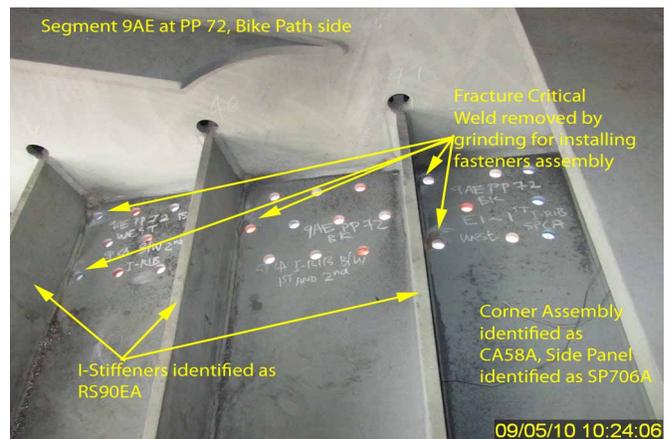
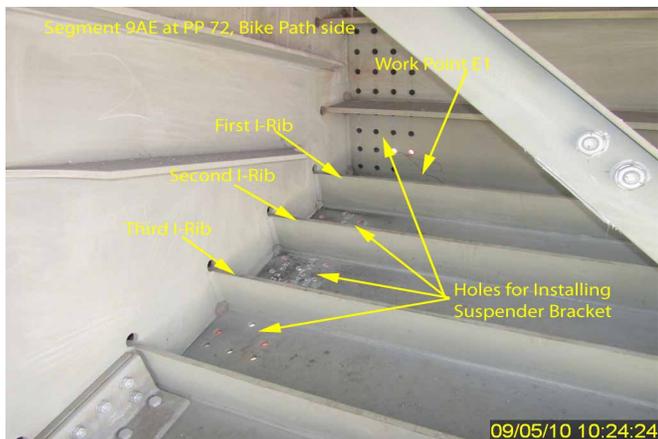
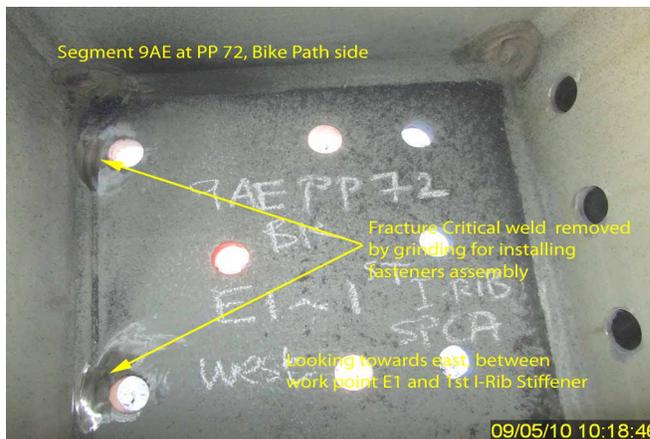
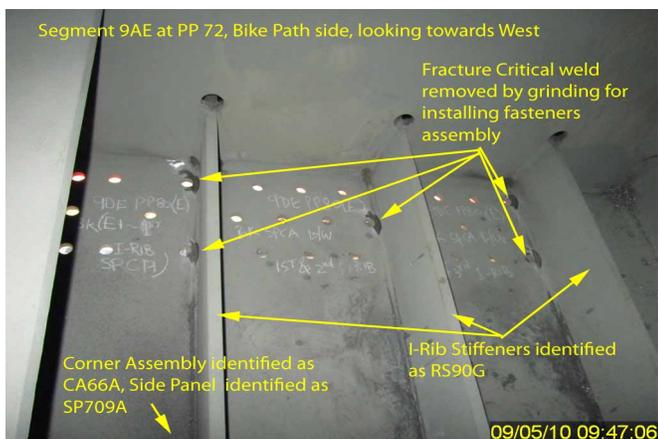
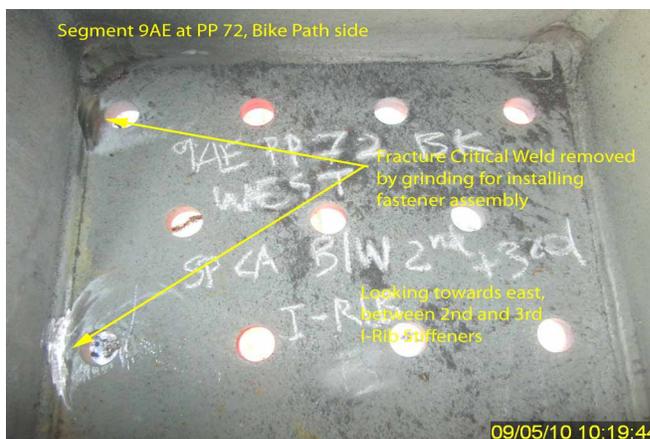
This Quality Assurance (QA) Inspector wrote an Incident Report for drilling hole too close the Fillet weld (which is designated as Fracture Critical Weld (FCW) as per approved shop drawing) and grinding off the fillet weld. The hole is drilled to facilitate installation of fasteners assembly connecting Suspender Bracket to Corner assembly, Bike Path Side at Panel Points (PP) 72, PP 74, PP 76, PP 78, PP 80, PP 82 and PP 84. Please reference the Incident Report # 04-0120F4_TL-15_B278_09-05-10_Lift 9E_drilled bolt hole_close to fillet weld_I-Stiffener_Bike Path side_at SPCA dated September 05, 2010 for further detail.

Please reference the pictures attached for more comprehensive details
