DEPARTMENT OF TRANSPORTATION

Contract #: 04-0120F4Cty: SF/ALA Rte: 80 PM: 13.2/13.9File #: 99.28**WELDING INSPECTION REPORT****Resident Engineer:** Siegenthaler, Peter**Address:** 333 Burma Road**City:** Oakland, CA 94607**Report No:** WIR-016588**Date Inspected:** 30-Aug-2010**Project Name:** SAS Superstructure**OSM Arrival Time:** 700**Prime Contractor:** American Bridge/Fluor Enterprises, a JV**OSM Departure Time:** 1900**Contractor:** Zhenhua Port Machinery Company, Ltd (ZPMC) Chanxing Island**Location:** Shanghai, China

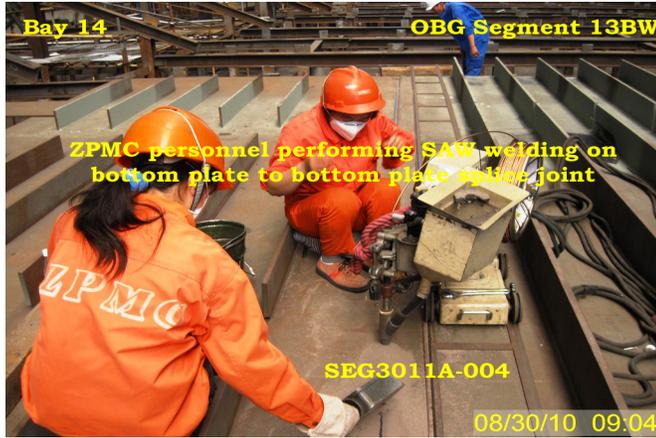
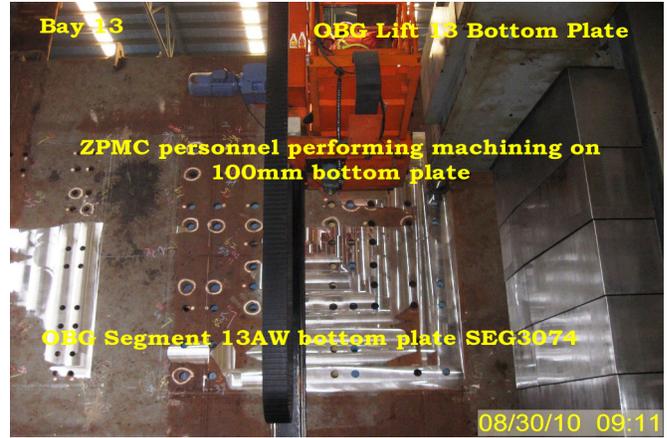
During random Quality Assurance Visual review of OBG Segment 13 lift Bottom Plate, this Quality Assurance Inspector (QA) observed machining of 100mm bottom plate at bay 13. The bottom plate is identified as OBG segment 13AW bottom plate BP3074. The bottom plate is identified as SPCM. See the attached pictures
