DEPARTMENT OF TRANSPORTATION

Quality Assurance and Source Inspection

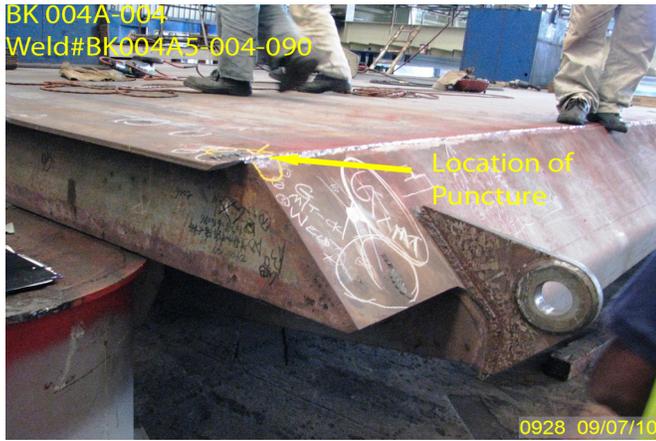
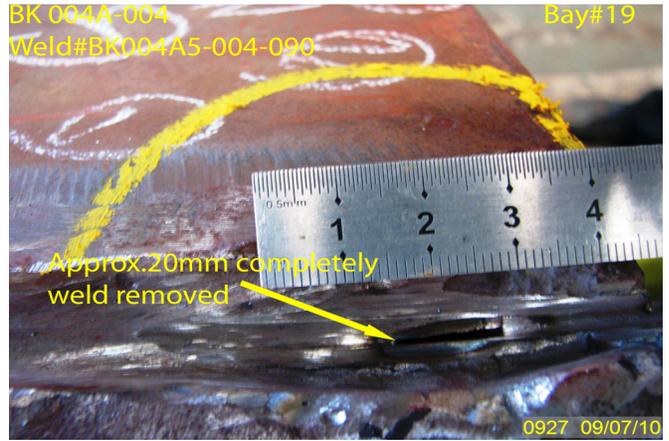
During random inprocess inspection of bike path BK004A-004 in fabrication Bay#19, this QA Inspector observed the following issues.

ZPMC MT technician performed magnetic particle inspection on the back gouging location of weld#BK0045-004-090.

During inspection, a linear indication measuring approximately 20mm in length found.

The weld is CJP butt joint, joining side plate to top plate.

ZPMC personnel grind out the total weld to remove the indication and make puncture.
