DEPARTMENT OF TRANSPORTATION

Quality Assurance and Source Inspection

Contract #: 04-0120F4Cty: SF/Ala Rte: 80 PM: 13.2/13.9File #: 69.28**WELDING INSPECTION REPORT****Resident Engineer:** Siegenthaler, Peter**Address:** 333 Burma Road**City:** Oakland, CA 94607**Report No:** WIR-016621**Date Inspected:** 30-Aug-2010**Project Name:** SAS Superstructure**OSM Arrival Time:** 1900**Prime Contractor:** American Bridge/Fluor Enterprises, a JV**OSM Departure Time:** 700**Contractor:** Zhenhua Port Machinery Company, Ltd (ZPMC), Changxing Island **Location:** Shanghai, China**CWI Name:** See below**CWI Present:** Yes No**Inspected CWI report:** Yes No N/A**Rod Oven in Use:** Yes No N/A**Electrode to specification:** Yes No N/A**Weld Procedures Followed:** Yes No N/A**Qualified Welders:** Yes No N/A**Verified Joint Fit-up:** Yes No N/A**Approved Drawings:** Yes No N/A**Approved WPS:** Yes No N/A**Delayed / Cancelled:** Yes No N/A**Bridge No:** 34-0006**Component:** Tower and OBG Components**Summary of Items Observed:**

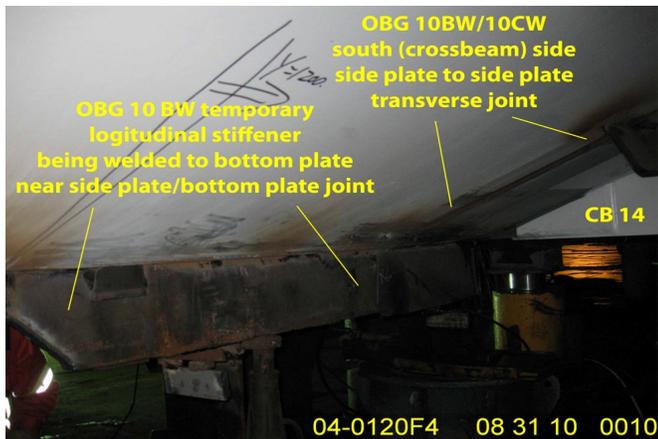
SMAW welding of temporary alignment stiffener plate located on PCMK OBG 10BW, bottom plate at the 10BW/10CW longitudinal joint between side plate and bottom plate on the south (crossbeam) side. See photo below. Welder was identified as 500433. QC was identified as QC2. Assisting QC2 at this location and appearing to be monitoring the welding and recording data was QCA3, who was not a CWI. Welding variables recorded by QCA3 appeared to comply with WPS-B-P-2114-FCM-1.
