**DEPARTMENT OF TRANSPORTATION**

Office of Structural Materials

Contract #: 04-0120F4Cty: SF/ALA Rte: 80 PM: 13.2/13.9File #: 69.28**WELDING INSPECTION REPORT****Resident Engineer:** Siegenthaler, Peter**Address:** 333 Burma Road**City:** Oakland, CA 94607**Report No:** WIR-016626**Date Inspected:** 07-Sep-2010**Project Name:** SAS Superstructure**OSM Arrival Time:** 700**Prime Contractor:** American Bridge/Fluor Enterprises, a JV**OSM Departure Time:** 1900**Contractor:** Zhenhua Port Machinery Company, Ltd (ZPMC), Changxing Island **Location:** Shanghai, China**CWI Name:** Zhu Zhong Hai.**CWI Present:** Yes No**Inspected CWI report:** Yes No N/A**Rod Oven in Use:** Yes No N/A**Electrode to specification:** Yes No N/A**Weld Procedures Followed:** Yes No N/A**Qualified Welders:** Yes No N/A**Verified Joint Fit-up:** Yes No N/A**Approved Drawings:** Yes No N/A**Approved WPS:** Yes No N/A**Delayed / Cancelled:** Yes No N/A**Bridge No:** 34-0006**Component:** OBG components.**Summary of Items Observed:**

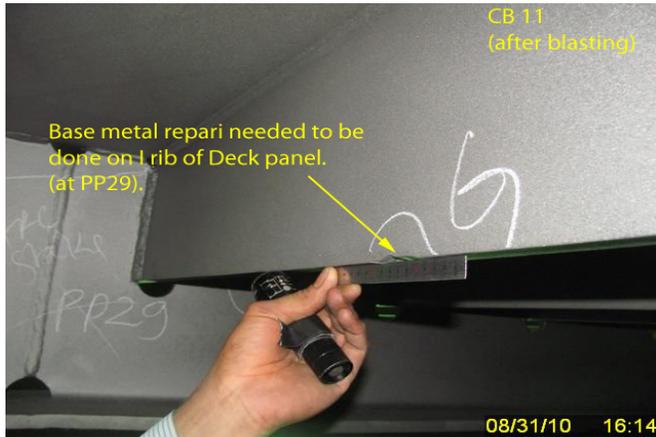
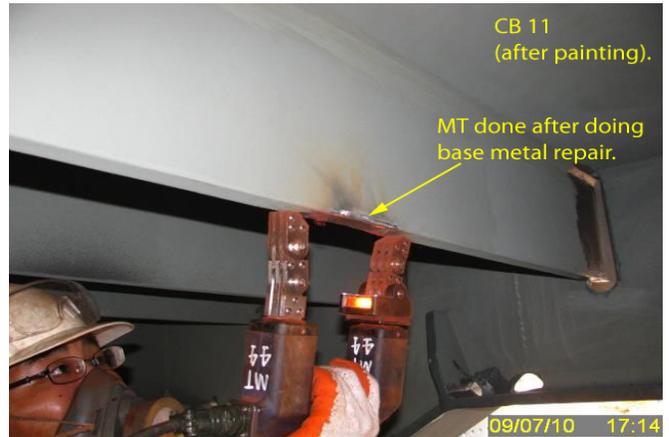
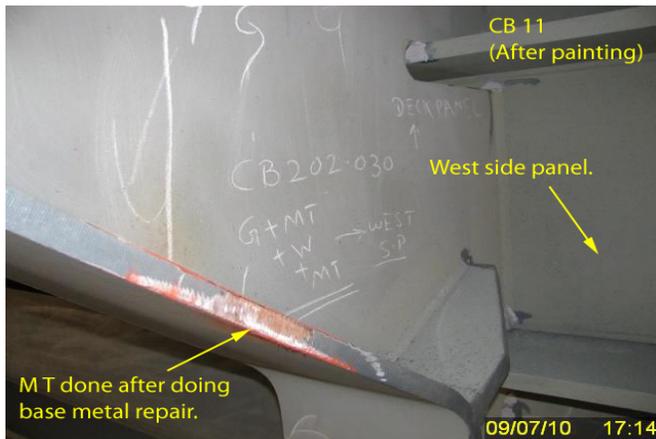
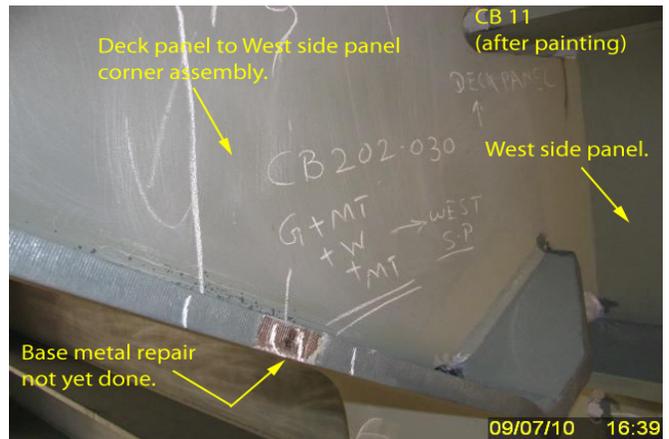
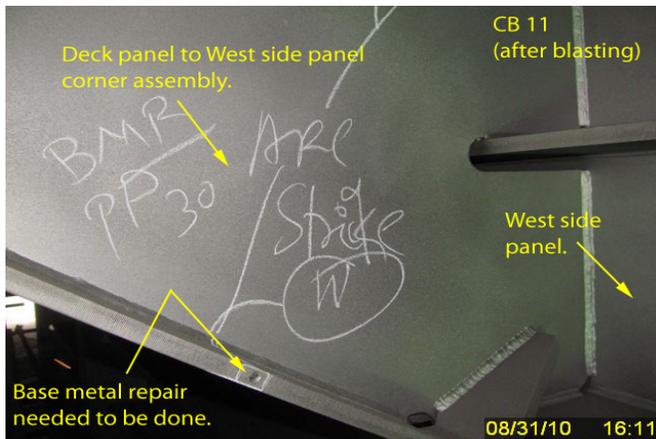
- During random visual inspection of this CB, this QA Inspector observed that for some of locations (identified for either repair / grinding, during blasting inspection), Magnetic Particle Testing (MT) was still to be done.
- At two locations base metal repair was still to be done.
- Earlier, during blasting inspection of CB11 (on 08/31/10), this QA Inspector identified and marked various locations / areas needed for grinding due to arc strikes.

- This QA Inspector did MT of these identified areas. The locations of the same were recorded on the drawings / weld maps and were submitted to the Task Leader for review.
- See attached photo for further details.
