DEPARTMENT OF TRANSPORTATION

Contract #: 04-0120F4Cty: SF/ALA Rte: 80 PM: 13.2/13.9File #: 1.28**WELDING INSPECTION REPORT****Resident Engineer:** Siegenthaler, Peter**Address:** 333 Burma Road**City:** Oakland, CA 94607**Report No:** WIR-016635**Date Inspected:** 31-Aug-2010**Project Name:** SAS Superstructure**OSM Arrival Time:** 1000**Prime Contractor:** American Bridge/Fluor Enterprises, a JV**OSM Departure Time:** 1830**Contractor:** American Bridge/Fluor Enterprises, a JV**Location:** Job Site**CWI Name:** See Below**CWI Present:** Yes No**Inspected CWI report:** Yes No N/A**Rod Oven in Use:** Yes No N/A**Electrode to specification:** Yes No N/A**Weld Procedures Followed:** Yes No N/A**Qualified Welders:** Yes No N/A**Verified Joint Fit-up:** Yes No N/A**Approved Drawings:** Yes No N/A**Approved WPS:** Yes No N/A**Delayed / Cancelled:** Yes No N/A**Bridge No:** 34-0006**Component:** Orthotropic Box Girders**Summary of Items Observed:**

WELDING INSPECTION REPORT

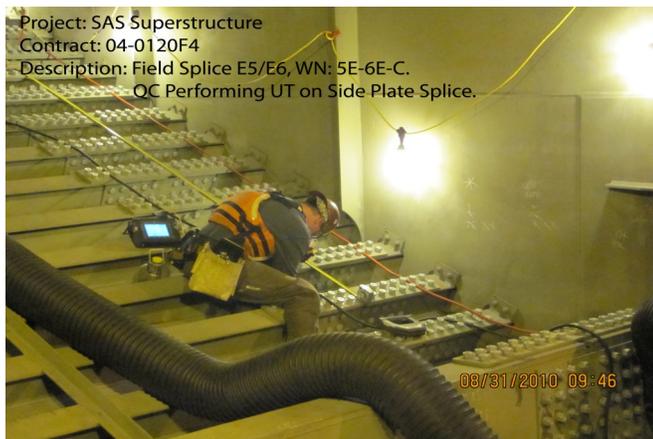
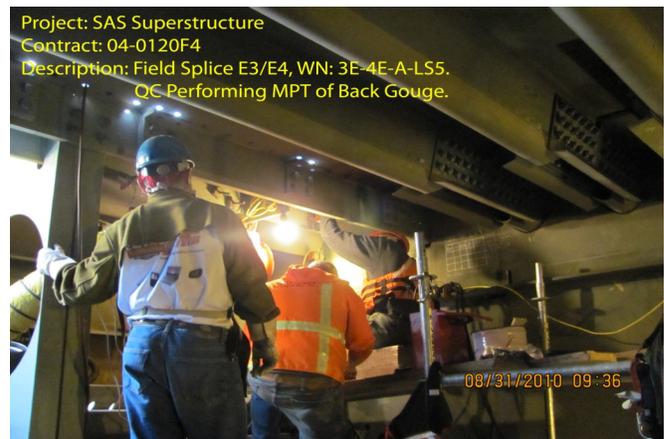
The digital photographs below illustrate the work observed during this scheduled shift.
