DEPARTMENT OF TRANSPORTATION

Contract #: 04-0120F4Cty: SF/ALA Rte: 80 PM: 13.2/13.9File #: 1.28**WELDING INSPECTION REPORT****Resident Engineer:** Siegenthaler, Peter**Address:** 333 Burma Road**City:** Oakland, CA 94607**Report No:** WIR-016637**Date Inspected:** 03-Sep-2010**Project Name:** SAS Superstructure**OSM Arrival Time:** 630**Prime Contractor:** American Bridge/Fluor Enterprises, a JV**OSM Departure Time:** 230**Contractor:** American Bridge/Fluor Enterprises, a JV**Location:** Jobsite**CWI Name:** See below**CWI Present:** Yes No**Inspected CWI report:** Yes No N/A**Rod Oven in Use:** Yes No N/A**Electrode to specification:** Yes No N/A**Weld Procedures Followed:** Yes No N/A**Qualified Welders:** Yes No N/A**Verified Joint Fit-up:** Yes No N/A**Approved Drawings:** Yes No N/A**Approved WPS:** Yes No N/A**Delayed / Cancelled:** Yes No N/A**Bridge No:** 34-0006**Component:** SAS OBG**Summary of Items Observed:**

WELDING INSPECTION REPORT

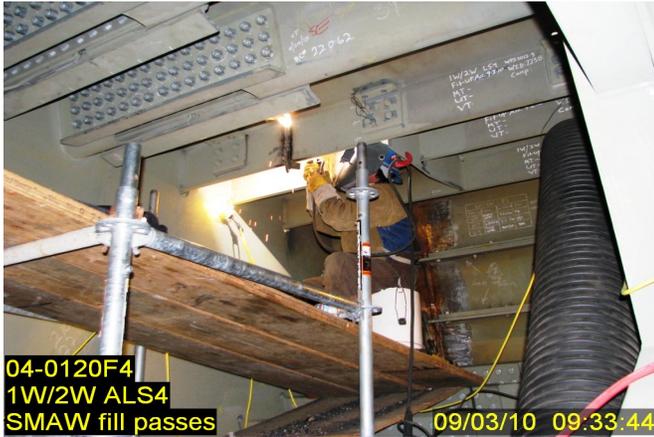
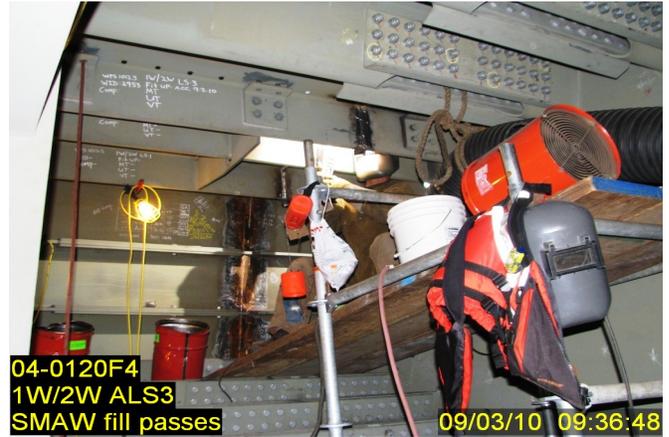
UT verified by the QAI for a distance of 500mm on the horizontal weld appeared to be in general compliance with contract documents. See Ultrasonic Testing Report Form TL-6027 and Magnetic Particle Testing Report Form TL-6028 generated by the QAI on this date.

After the QAI completed the Verification Testing on this date the QAI spoke with QC Inspector Mr. Leonard Cross. See Summary of Conversations below.
