Contract #: 04-0120F4Cty: SF/ALA Rte: 80 PM: 13.2/13.9File #: 1.28**WELDING INSPECTION REPORT****Resident Engineer:** Siegenthaler, Peter**Address:** 333 Burma Road**City:** Oakland, CA 94607**Report No:** WIR-016641**Date Inspected:** 01-Sep-2010**Project Name:** SAS Superstructure**OSM Arrival Time:** 630**Prime Contractor:** American Bridge/Fluor Enterprises, a JV**OSM Departure Time:** 1500**Contractor:** American Bridge/Fluor Enterprises, a JV**Location:** Jobsite**CWI Name:** See below**CWI Present:** Yes No**Inspected CWI report:** Yes No N/A**Rod Oven in Use:** Yes No N/A**Electrode to specification:** Yes No N/A**Weld Procedures Followed:** Yes No N/A**Qualified Welders:** Yes No N/A**Verified Joint Fit-up:** Yes No N/A**Approved Drawings:** Yes No N/A**Approved WPS:** Yes No N/A**Delayed / Cancelled:** Yes No N/A**Bridge No:** 34-0006**Component:** SAS OBG**Summary of Items Observed:**

On this date CALTRANS OSM Quality Assurance Inspector (QAI) Bert Madison was present at Yerba Buena Island in California between the times noted above for observations relative to the work being performed by American Bridge/Fluor Enterprises (AB/F) personnel at the locations noted below.

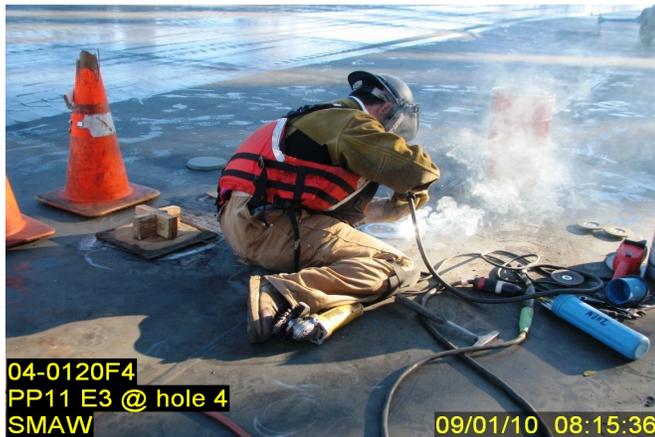
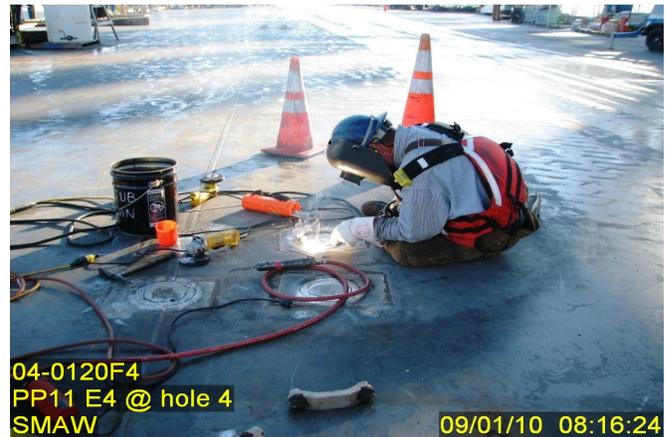
The QAI periodically observed AB/F approved welders Rick Clayborn (ID 2773) and James Zhen (ID 6001) performing welding per the SMAW process in the 1G (flat) position to restore Lifting Lug Holes. Mr. Clayborn was observed welding PP11 E4 at hole 4 and Mr. Zhen was observed welding at PP11 E3 at hole 4. See photos below. The QAI also observed AB/F approved welder Jin Pei Wang on the interior side of the A deck back grinding at weld PP8.5 E3 at hole 3. The QAI observed QC Inspector Tony Sherwood was periodically present to monitor the progress and verify that the welding parameters were within the limits established by the approved Welding Procedure Specification (WPS) identified as ABF-WPS-D1.5-1050A-1. The QAI spoke with Mr. Sherwood regarding the electrodes being used at this location. See Summary of Conversations. The QAI observed that the work at this location was in process for the duration of the shift and appeared to be in general compliance with contract documents.

The QAI in a conversation with QC Mr. Sherwood was told that the electrodes used to restore the lifting lug holes are 3 different sizes. He stated that a 3.2 mm electrode is used for the root pass, a 4 mm for the fill passes and a 4.8 mm electrode for the fill and covers. He stated that the welding amperage must be increased with each increase in electrode size.
