DEPARTMENT OF TRANSPORTATION

Quality Assurance and Source Inspection

Contract #: 04-0120F4Cty: SF/ALA Rte: 80 PM: 13.2/13.9File #: 1.28**WELDING INSPECTION REPORT****Resident Engineer:** Siegenthaler, Peter**Address:** 333 Burma Road**City:** Oakland, CA 94607**Report No:** WIR-016649**Date Inspected:** 07-Sep-2010**Project Name:** SAS Superstructure**OSM Arrival Time:** 1000**Prime Contractor:** American Bridge/Fluor Enterprises, a JV**OSM Departure Time:** 1830**Contractor:** American Bridge/Fluor Enterprises, a JV**Location:** Job Site

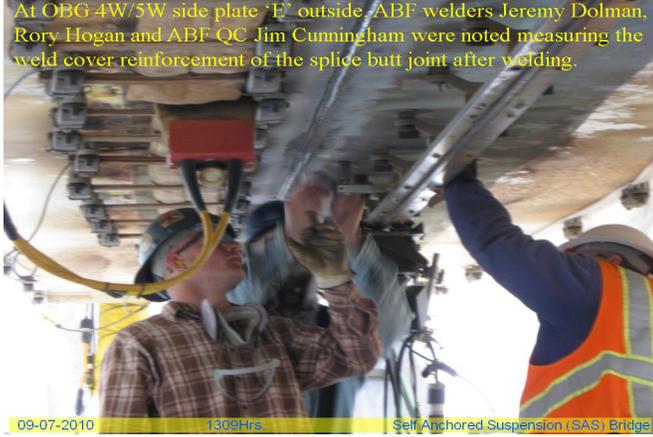
QA randomly observed ABF/JV qualified welders Rory Hogan (ID #3186) and Jeremy Dolman (ID #5042) continuing to perform CJP groove (splice) back welding fill pass on Orthotropic Box Girder (OBG) 4W/5W side plate 'E1' outside. The welder was observed welding in the 4G (overhead) position utilizing a dual shield Flux Cored Arc Welding (FCAW-G) with E71T-1M, 1/16" diameter wire electrode and implementing Caltrans approved Welding Procedure Specification (WPS) ABF-WPS-D15-3110-4. The welder was using a track mounted welder holder assembly that was remotely controlled. The joint being welded has the backing bar gouged using the Esab Plasma Arc machine and was ground smooth. The gouged and ground splice butt joint was also Non Destructive Testing (NDT) tested using the Magnetic Particle Testing (MT). The splice joint was preheated to greater than 150 degrees Fahrenheit using Miller Proheat 35 Induction Heating System located on top of the plate prior and maintained the preheat by moving the heater blankets on the side of the plate during welding. The vicinity was also properly protected from wind and other climatic changes. During welding, ABF Quality Control (QC) Jim Cunningham was noted monitoring the welding parameters of the welder. Fill pass welding was still continuing at the end of the shift and should remain tomorrow.

At OBG-4W/5W side plate 'E' outside ABF welders Jeremy Dolman, Rory Hogan and ABF QC Jim Cunningham were noted measuring the weld cover reinforcement of the splice butt joint after welding.

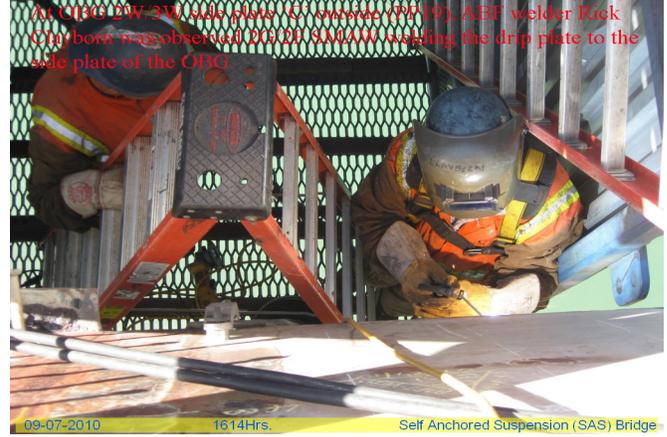
At OBG 2W/3W side plate 'C' outside, QA randomly observed ABF welder Rick Clayborn continuing to perform fillet and partial joint penetration (PJP) welding in 2F/2G position using Shielded Metal Arc Welding (SMAW) with 1/8" diameter E7018H4R electrode. The welder was welding on 2 1/4" wide x 3/8" thick drip plate to the side

plate of the OBG at panel point PP19. The drip plate and the surface of the side plate (where the drip plate was welded) were noted ground and the paint coating removed. ABF QC Jesse Cayabyab was noted monitoring the welding and its parameters. At the end of the shift, fillet and PJP welding of the drip plate to the side plate were completed and was visually accepted by QC Jesse Cayabyab.

At OBG-2W-3W side plate 'C' outside (PP19), ABF welder Dick Chybora was observed welding the drip plate to the side plate of the OBG.
