Contract #: 04-0120F4Cty: SF/ALA Rte: 80 PM: 13.2/13.9File #: 69.28**WELDING INSPECTION REPORT****Resident Engineer:** Siegenthaler, Peter**Address:** 333 Burma Road**City:** Oakland, CA 94607**Report No:** WIR-016659**Date Inspected:** 09-Sep-2010**Project Name:** SAS Superstructure**OSM Arrival Time:** 700**Prime Contractor:** American Bridge/Fluor Enterprises, a JV**OSM Departure Time:** 1900**Contractor:** Zhenhua Port Machinery Company, Ltd (ZPMC), Changxing Island **Location:** Shanghai, China**CWI Name:** Zhu Zhong Hai.**CWI Present:** Yes No**Inspected CWI report:** Yes No N/A**Rod Oven in Use:** Yes No N/A**Electrode to specification:** Yes No N/A**Weld Procedures Followed:** Yes No N/A**Qualified Welders:** Yes No N/A**Verified Joint Fit-up:** Yes No N/A**Approved Drawings:** Yes No N/A**Approved WPS:** Yes No N/A**Delayed / Cancelled:** Yes No N/A**Bridge No:** 34-0006**Component:** OBG components.**Summary of Items Observed:**

OBG Seg 11EE (Green Tag DCP):

For Cross Beam 12 (CB12):

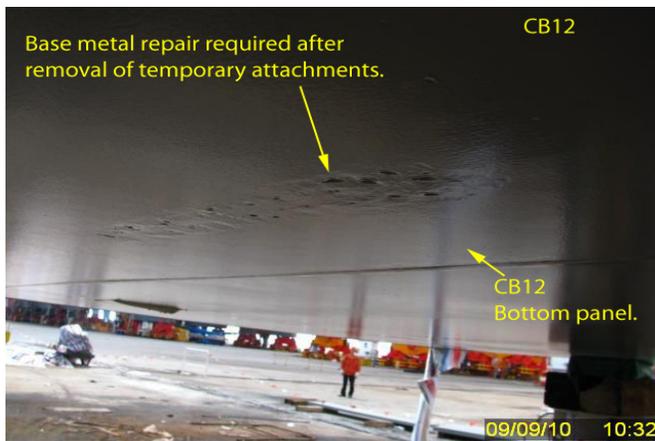
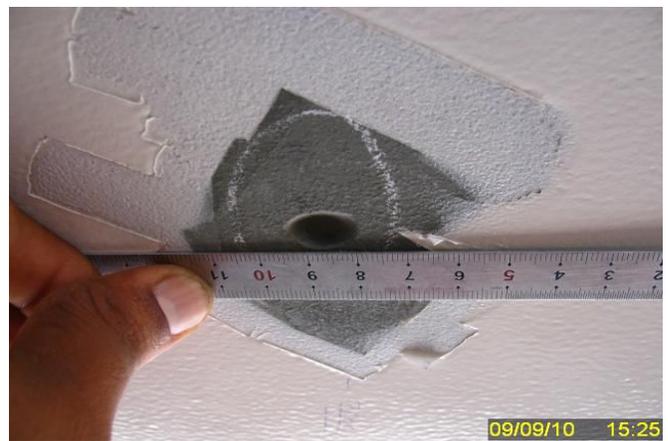
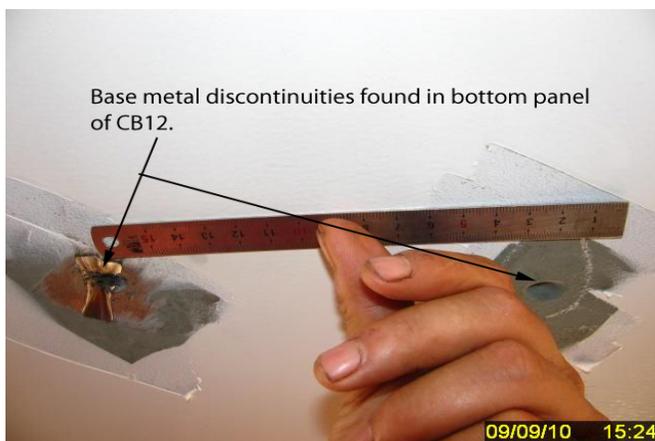
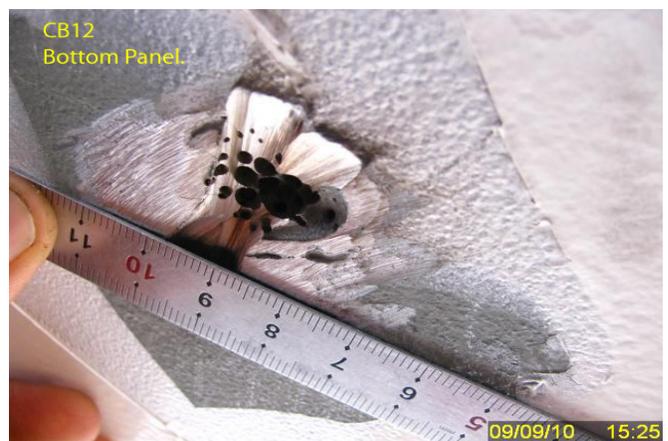
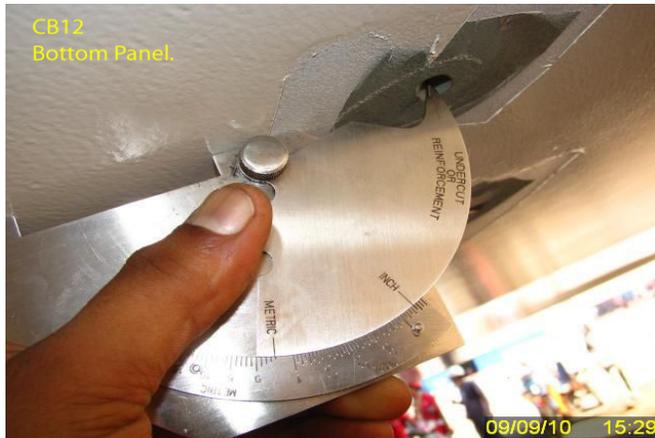
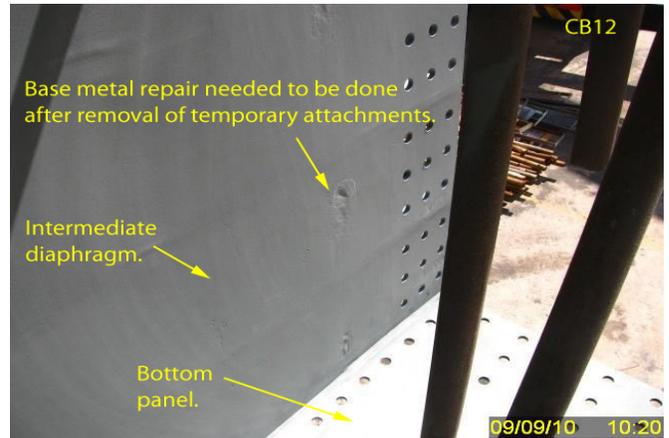
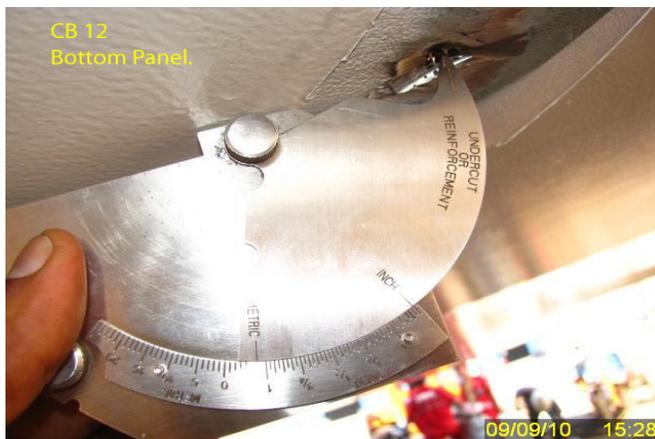
This QA Inspector did visual inspection (VT) of the above mentioned CB for its punch list item no 395. It was observed that none of the noted punch list item was attended for repair. This was informed to ZPMC Quality Control (QC) Mr. Xu Xing Ping.

Additional to the punch items, this QA Inspector observed base metal porosity on the bottom panel (outer surface) of this CB. This QA Inspector informed ZPMC QC to ensure a Critical Welding Report (CWR) is approved before any repair welding is done.
