**DEPARTMENT OF TRANSPORTATION**

Contract #: 04-0120F4Cty: SF/ALA Rte: 80 PM: 13.2/13.9File #: 69.28**WELDING INSPECTION REPORT****Resident Engineer:** Siegenthaler, Peter**Address:** 333 Burma Road**City:** Oakland, CA 94607**Report No:** WIR-016671**Date Inspected:** 30-Aug-2010**Project Name:** SAS Superstructure**OSM Arrival Time:** 700**Prime Contractor:** American Bridge/Fluor Enterprises, a JV**OSM Departure Time:** 1900**Contractor:** Zhenhua Port Machinery Company, Ltd (ZPMC), Changxing Island **Location:** Shanghai, China**CWI Name:** Zhao Chen Sun**CWI Present:** Yes No**Inspected CWI report:** Yes No N/A**Rod Oven in Use:** Yes No N/A**Electrode to specification:** Yes No N/A**Weld Procedures Followed:** Yes No N/A**Qualified Welders:** Yes No N/A**Verified Joint Fit-up:** Yes No N/A**Approved Drawings:** Yes No N/A**Approved WPS:** Yes No N/A**Delayed / Cancelled:** Yes No N/A**Bridge No:** 34-0006**Component:** Tower Components**Summary of Items Observed:**

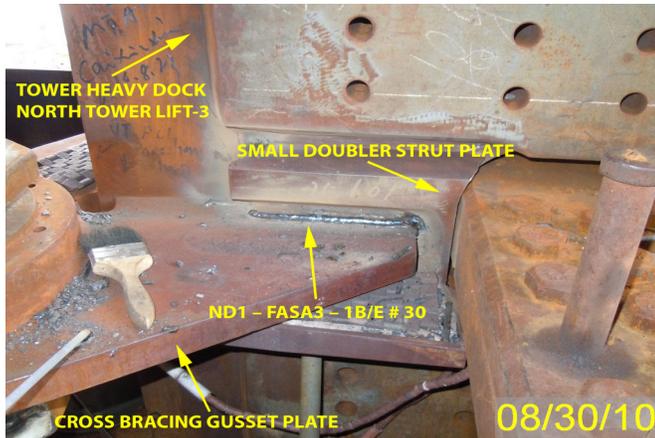
Weld joint # 29 located on North tower Lift-3 cross bracing gusset plate to small doubler plate ND1 – FASA3 – 1B/E. Welder is identified as 040690. ZPMC Quality Control (QC) Inspector is identified Zhao Chen Sun. The welding variables recorded by QC appeared to comply with the WPS – B – P – 4214– Tc – U4c.

Repair welding of a weld joint # 3B located on West tower Lift-3 cross bracing gusset plate WD1 – GUSA3 – 3 – 109M – W as per the weld repair report # T-WR3536. Welder is identified as 202323. ZPMC Quality Control (QC) Inspector is identified Zhao Chen Sun. The welding variables recorded by QC appeared to comply with the WPS – 345 – SMAW – 2G (2F) – Repair.

Weld joint # 30 located on North tower Lift-3 cross bracing gusset plate to small doubler plate ND1 – FASA3 – 1B/E. Welder is identified as 040690. ZPMC Quality Control (QC) Inspector is identified Zhao Chen Sun. The welding variables recorded by QC appeared to comply with the WPS – B – P – 4212 – Tc – U4c – 4.

(See attached photo)

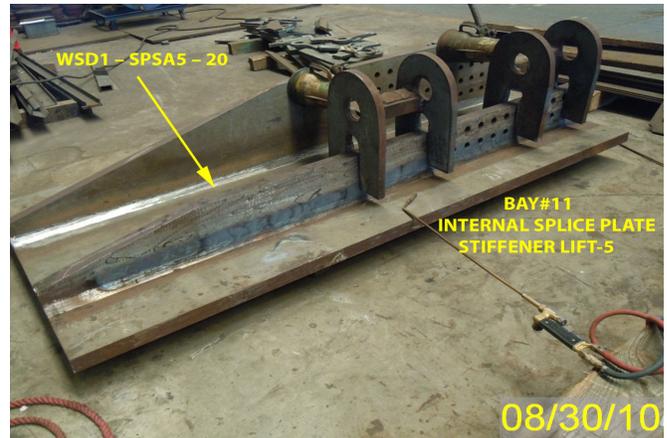
Heat Straightening being performed on Internal Splice Plate Stiffener identified as WSD1 – SPSA5 – 20 by oxy-acetylene flame method to remove the distortion that occurred after welding. ZPMC Quality Control (QC) Inspector is identified as Shang Hai Long present at the location. This activity appeared to comply with the Heat Straightening Report # HSR1 (T) – 11471. (See attached Photo)
