DEPARTMENT OF TRANSPORTATION

Contract #: 04-0120F4Cty: SF/ALA Rte: 80 PM: 13.2/13.9File #: 99.28**WELDING INSPECTION REPORT****Resident Engineer:** Siegenthaler, Peter**Address:** 333 Burma Road**City:** Oakland, CA 94607**Report No:** WIR-016693**Date Inspected:** 12-Sep-2010**Project Name:** SAS Superstructure**OSM Arrival Time:** 700**Prime Contractor:** American Bridge/Fluor Enterprises, a JV**OSM Departure Time:** 1900**Contractor:** Zhenhua Port Machinery Company, Ltd (ZPMC)**Location:** Shanghai, China

Orthotropic Box Girder (OBG) at Trial Assembly Areas

Segment 9BE to Segment 9CE (Retrofit Installed at Skin Flatness out of Tolerance areas)

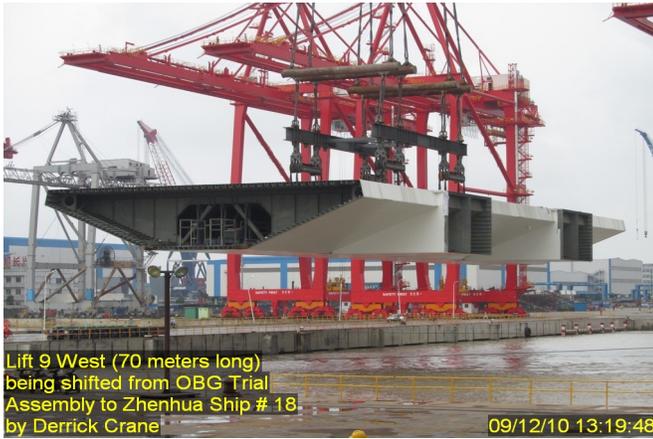
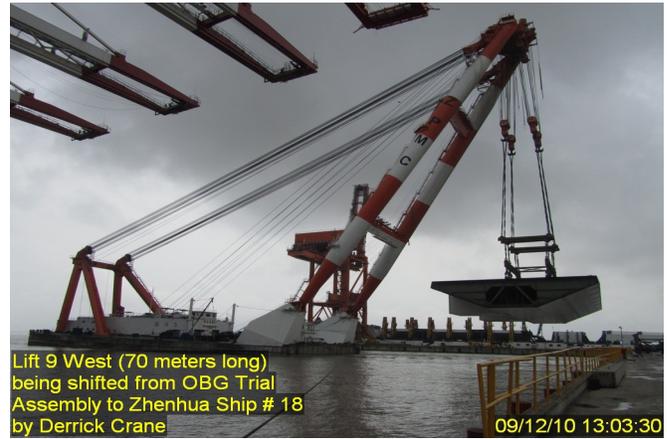
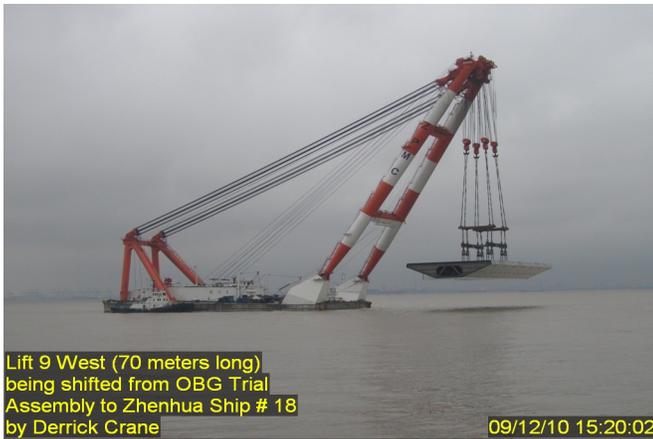
This QA Inspector observed that Lift 9 (West) 70 meters long been transported from trail assembly yard to the ZPMC ship # 18 by Derrick Barge and will be placed on top of Lift 9 (East). Please reference the pictures attached for more comprehensive details.
