DEPARTMENT OF TRANSPORTATION

Quality Assurance and Source Inspection

Contract #: 04-0120F4Cty: SF/ALA Rte: 80 PM: 13.2/13.9File #: 1.28**WELDING INSPECTION REPORT****Resident Engineer:** Siegenthaler, Peter**Address:** 333 Burma Road**City:** Oakland, CA 94607**Report No:** WIR-016702**Date Inspected:** 07-Sep-2010**Project Name:** SAS Superstructure**OSM Arrival Time:** 630**Prime Contractor:** American Bridge/Fluor Enterprises, a JV**OSM Departure Time:** 1500**Contractor:** American Bridge/Fluor Enterprises, a JV**Location:** Job Site**CWI Name:** See below**CWI Present:** Yes No**Inspected CWI report:** Yes No N/A**Rod Oven in Use:** Yes No N/A**Electrode to specification:** Yes No N/A**Weld Procedures Followed:** Yes No N/A**Qualified Welders:** Yes No N/A**Verified Joint Fit-up:** Yes No N/A**Approved Drawings:** Yes No N/A**Approved WPS:** Yes No N/A**Delayed / Cancelled:** Yes No N/A**Bridge No:** 34-0006**Component:** SAS OBG**Summary of Items Observed:**

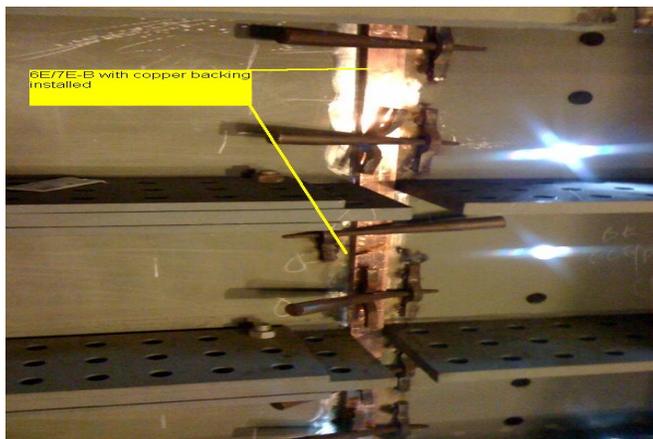
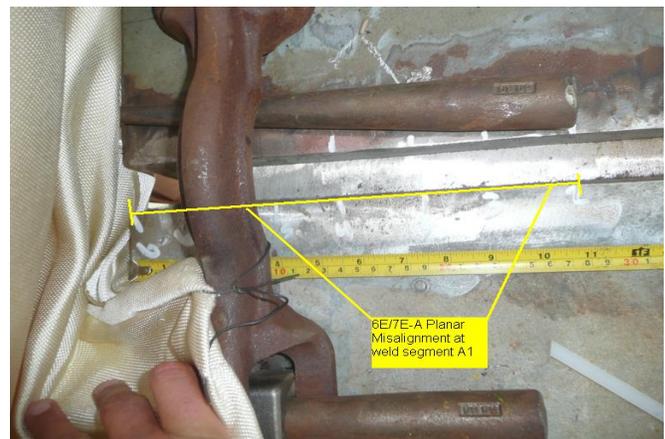
Upon the arrival of the QA Inspector in the am it was observed the above identified weld joint was fit up with the approved temporary attachments or fit up gear in place. Upon the arrival of the QA Inspector, the QC and the QA Inspector performed dimensional measurements of the planar misalignment and noted the planar misalignment appeared to be minimal on the above identified weld joint. The QA Inspector noted the only unacceptable planar misalignment in the entire weld joint was in weld segment A1 and A5. The QA Inspector measured approximately 280mm of planar misalignment beginning at A1 and spanning toward A2. The QA Inspector noted the misalignment was measured at 5mm-6mm. The QA Inspector noted the misalignment at the end of A5 and spanned 65mm toward A4 the QA Inspector noted an incident report was written and submitted for review. The unacceptable planar misalignment was located at the following 4 locations:

The QA Inspector and the SE QC Inspector Bonifacio Daquinag performed dimensional verification of the gaps at the steel backing. The QA Inspector noted the following areas have a gap between the steel backing and the bevel that are greater than 2mm:

The QA Inspector noted the above identified locations will require engineering approval prior to performing any weld repairs. The QA Inspector noted the locations were submitted by SE to ABF and the approval was given by the Project Engineer Patrick Lowry (see summary of conversation)

The SMR Patrick Lowry gave verbal approval to weld over the gaps at the steel backing on the transverse weld splice identified as 6E/7E-A at 1400 on this date.
