**DEPARTMENT OF TRANSPORTATION**

Contract #: 04-0120F4Cty: SF/ALA Rte: 80 PM: 13.2/13.9File #: 1.28**WELDING INSPECTION REPORT****Resident Engineer:** Siegenthaler, Peter**Address:** 333 Burma Road**City:** Oakland, CA 94607**Report No:** WIR-016705**Date Inspected:** 10-Sep-2010**Project Name:** SAS Superstructure**OSM Arrival Time:** 1000**Prime Contractor:** American Bridge/Fluor Enterprises, a JV**OSM Departure Time:** 1730**Contractor:** American Bridge/Fluor Enterprises, a JV**Location:** Job Site

<b>CWI Name:</b>	Jesse Cayabyab and John Pagliero			<b>CWI Present:</b>	<b>Yes</b>	<b>No</b>	
<b>Inspected CWI report:</b>	<b>Yes</b>	<b>No</b>	<b>N/A</b>	<b>Rod Oven in Use:</b>	<b>Yes</b>	<b>No</b>	<b>N/A</b>
<b>Electrode to specification:</b>	<b>Yes</b>	<b>No</b>	<b>N/A</b>	<b>Weld Procedures Followed:</b>	<b>Yes</b>	<b>No</b>	<b>N/A</b>
<b>Qualified Welders:</b>	<b>Yes</b>	<b>No</b>	<b>N/A</b>	<b>Verified Joint Fit-up:</b>	<b>Yes</b>	<b>No</b>	<b>N/A</b>
<b>Approved Drawings:</b>	<b>Yes</b>	<b>No</b>	<b>N/A</b>	<b>Approved WPS:</b>	<b>Yes</b>	<b>No</b>	<b>N/A</b>
				<b>Delayed / Cancelled:</b>	<b>Yes</b>	<b>No</b>	<b>N/A</b>
<b>Bridge No:</b>	34-0006			<b>Component:</b>	Ortho

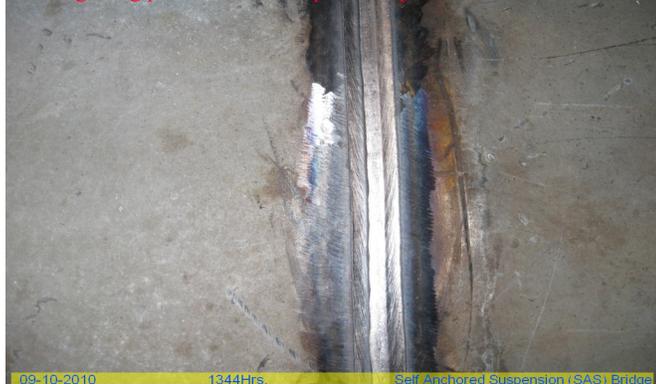
09-10-2010 1344Hrs. Self Anchored Suspension (SAS) Bridge

At OBG 6E/7E top deck plate A1 to A5, QA randomly observed two ABF certified welders Bryce Howell ID #5591 and Mike Maday ID #3391 perform 1G (flat position) Submerged Arc Welding (SAW). The welders were utilizing F7A6-EM12K-H8, 3.2mm electrode with corresponding Esab OK Flux 10.62 flux and implementing Caltrans approved Welding Procedure Specification (WPS) ABF-WPS-D15-4042B-1. The two welders were welding simultaneously in two separate locations (A1 to A3 and A3 to A5) with two separate welding machines. The joint being welded had a single V-groove butt joint with backing bar. The plates were preheated to more than 150 degree Fahrenheit using Miller Proheat 35 Induction Heating System located on top of the plate prior welding and maintained the preheat by moving the heater blankets on the side of the plate during welding. Welding parameters were monitored by two separate ABF/QC Steven Mc Connell (for Mike Maday) and Jesse Cayabyab (for Bryce Howell). QA noted the welding parameters, the workmanship and appearances of the completed fill passes satisfactory and were deemed acceptable to contract requirements. At the end of the shift, SAW welding was still continuing and should continue tomorrow.

At OBG 6E/7E top deck plate 'A' outside, surface profile of the SAW welding being performed at the splice butt joint.

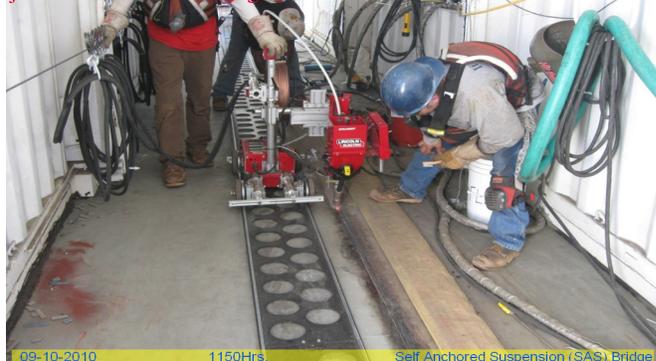
09-10-2010 1150Hrs. Self Anchored Suspension (SAS) Bridge

At OBG 6E/7E bottom plate 'D' inside, ABF welder Mike Maday was noted performing Submerged Arc Welding (SAW) on the splice butt joint. The welder was using Lincoln Electric track mounted feeder.

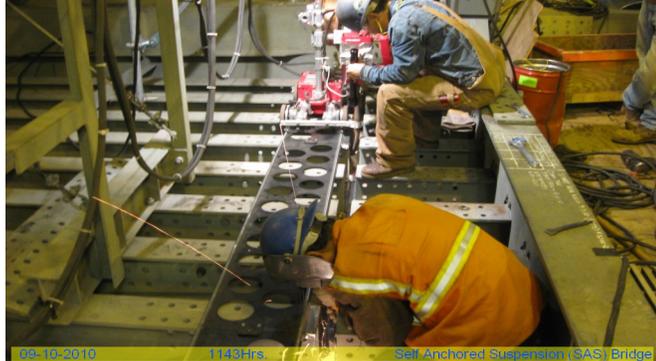
09-10-2010 1149Hrs. Self Anchored Suspension (SAS) Bridge

At OBG 6E/7E bottom plate 'D', QA randomly observed ABF certified welders James Zhen ID #6001 and Songtao, Huang ID #3794 perform 1G (flat position) Submerged Arc Welding (SAW). The welders were utilizing F7A6-EM12K-H8, 3.2mm electrode with corresponding Esab OK Flux 10.62 flux and implementing Caltrans approved Welding Procedure Specification (WPS) ABF-WPS-D15-4042B-1. The joint being welded had a single

V-groove butt joint with backing bar. The plates were preheated to more than 150 degree Fahrenheit using Miller Proheat 35 Induction Heating System located at the opposite side of the plate prior/during welding. Welding parameters were monitored by ABF/QC John Pagliero. QA noted the welding parameters, the workmanship and appearances of the completed fill and cover passes satisfactory and were deemed acceptable to contract requirements. At the end of the shift, SAW welding was completed on most of the splice butt joint except at north end (600mm) and south end (1000mm) wherein the Lincoln Electric feeder track has limited access to both ends. According to QC John Pagliero, the welders will perform manual welding on those two locations tomorrow.

At OBG 6E/7E bottom plate 'D' inside, ABF welders James Zhen and Songtao, Huang were noted performing Submerged Arc Welding (SAW) on the splice butt joint.

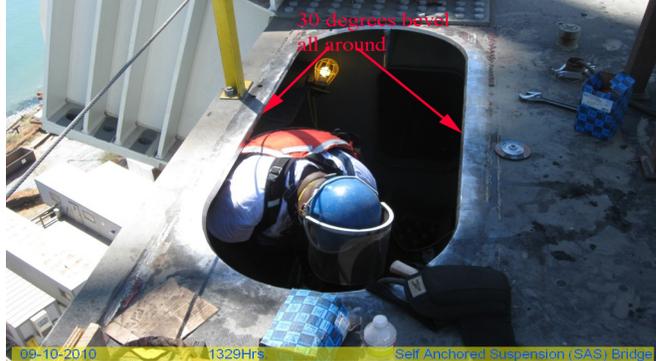
09-10-2010 1329Hrs. Self Anchored Suspension (SAS) Bridge

At OBG 1W top deck plate 'A' outside, ABF welder Fred Kaddu was observed grinding/beveling the edges of the manhole cover to 30 degrees in preparation for the CJP welding of the joint.
