DIVISION OF ENGINEERING SERVICES

Contract #: 04-0120F4Cty: SF/ALA Rte: 80 PM: 13.2/13.9File #: 1.28**WELDING INSPECTION REPORT****Resident Engineer:** Siegenthaler, Peter**Address:** 333 Burma Road**City:** Oakland, CA 94607**Report No:** WIR-016707**Date Inspected:** 11-Sep-2010**Project Name:** SAS Superstructure**OSM Arrival Time:** 700**Prime Contractor:** American Bridge/Fluor Enterprises, a JV**OSM Departure Time:** 1530**Contractor:** American Bridge/Fluor Enterprises, a JV**Location:** Jobsite**CWI Name:** See below**CWI Present:** Yes No**Inspected CWI report:** Yes No N/A**Rod Oven in Use:** Yes No N/A**Electrode to specification:** Yes No N/A**Weld Procedures Followed:** Yes No N/A**Qualified Welders:** Yes No N/A**Verified Joint Fit-up:** Yes No N/A**Approved Drawings:** Yes No N/A**Approved WPS:** Yes No N/A**Delayed / Cancelled:** Yes No N/A**Bridge No:** 34-0006**Component:** SAS OBG**Summary of Items Observed:**

WELDING INSPECTION REPORT

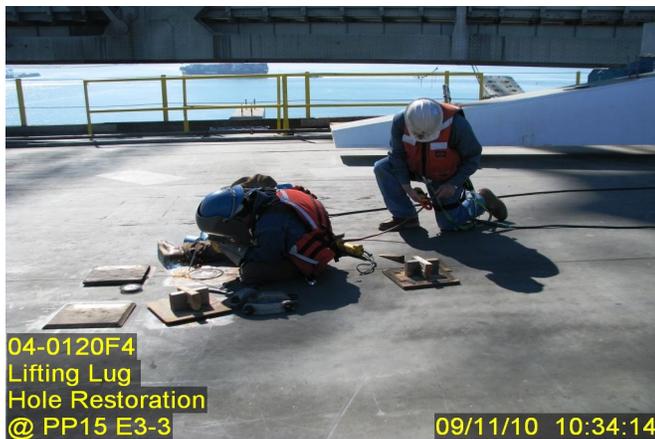
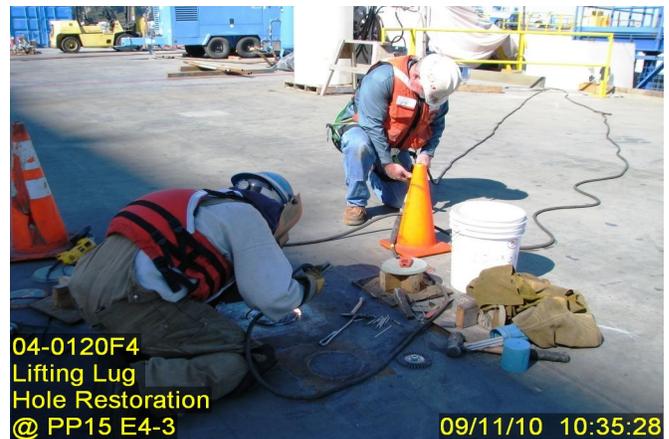
The QAI periodically observed the fit-up and welding per the SMAW process to restore the Lifting Lug Access holes in the A deck at PP15. The QAI observed that AB/F approved welder Yao Xin Liang (ID 7238) was working at weld E3-3 and that AB/F approved welder Wai Kitlai (ID 2953) was working at weld E4-3. See photos below. QC Inspector Mike Johnson was periodically present to monitor the progress and verify that the welding parameters were within the limits established by the approved welding Procedure Specification (WPS) identified as ABF-WPS-D1.5-1050B. Welding from the exterior was completed at these locations on this date. The QAI observed that the work appeared to be in general compliance with contract documents.
