DEPARTMENT OF TRANSPORTATION

Quality Assurance and Source Inspection

Contract #: 04-0120F4Cty: SF/ALA Rte: 80 PM: 13.2/13.9File #: 1.28**WELDING INSPECTION REPORT****Resident Engineer:** Siegenthaler, Peter**Address:** 333 Burma Road**City:** Oakland, CA 94607**Report No:** WIR-016811**Date Inspected:** 13-Sep-2010**Project Name:** SAS Superstructure**OSM Arrival Time:** 630**Prime Contractor:** American Bridge/Fluor Enterprises, a JV**OSM Departure Time:** 1500**Contractor:** American Bridge/Fluor Enterprises, a JV**Location:** Job Site**CWI Name:** See below**CWI Present:** Yes No**Inspected CWI report:** Yes No N/A**Rod Oven in Use:** Yes No N/A**Electrode to specification:** Yes No N/A**Weld Procedures Followed:** Yes No N/A**Qualified Welders:** Yes No N/A**Verified Joint Fit-up:** Yes No N/A**Approved Drawings:** Yes No N/A**Approved WPS:** Yes No N/A**Delayed / Cancelled:** Yes No N/A**Bridge No:** 34-0006**Component:** SAS OBG**Summary of Items Observed:**

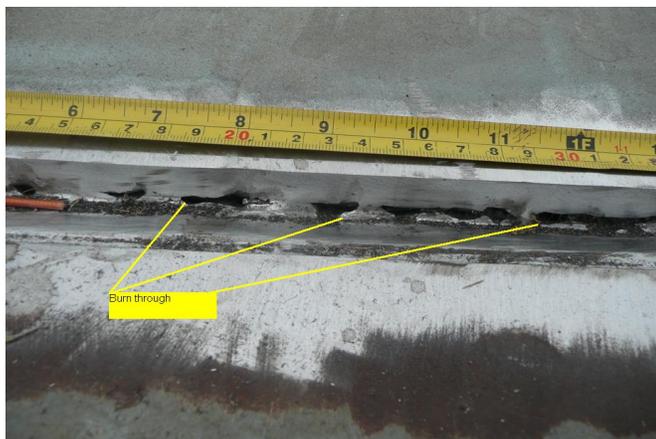
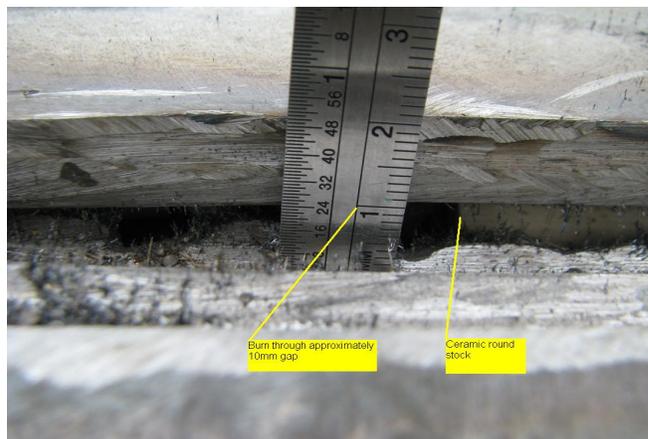
Upon the arrival of the QA Inspector at the above identified location, it was observed the top deck transverse weld splice had been previously completed except for approximately 1000mm. The QA Inspector noted on the previous day shift the ABF welding personnel had a machine malfunction and a section of the weld blew through the steel backing bar. The QA Inspector randomly observed the area of weld joint between y=2000mm-3025mm had blown through the steel backing bar at the edge of the backing and created a gap. The QA Inspector performed random dimensional measurements of the uneven gaps and noted the gaps appeared to be 3mm-9mm wide at various locations. The QA Inspector randomly observed the ABF Welding Superintendent Dan Ieraci was on site and attempting to install ceramic backing (see summary of conversation). The QA Inspector randomly observed Mr. Ieraci install the ceramic round bar stock adjacent to the steel backing under the top deck plate. The QA Inspector noted a weld dam was created to allow the gap created by the blow through to be restored and welded from the top side of the weld joint. The QA Inspector randomly observed Mr. Ieraci perform additional grinding create a weldable profile for the ABF welder. The QA Inspector noted no welding was performed on the QA Inspectors shift.

The ABF Welding Quality Control Manager (WQCM) Jim Bowers informed the QA Inspector an internal non conformance report was written in regards to area of the weld joint that is blown through. Mr. Bowers went on to inform the QA Inspector ABF is currently attempting to weld and restore the top side of the weld joint only. Mr. Bowers elaborated and said the bottom side of the weld joint at the steel backing will be fixed at a later date.

ABF Welding Superintendent Dan Ieraci informed the QA Inspector he will install ceramic round bar stock with adhesive to the bottom side of the steel backing bar at 6E/7E-A1 between y=2000mm-3025mm. Mr. Ieraci informed the QA Inspector he would install the ceramic backing to in an attempt to create a weld dam to begin the restoration of the weld joint. Mr. Ieraci went on to inform the QA Inspector once the ceramic is in place the ABF welder will deposit a SMAW pass from the top side of the weld joint and seal off the gap which was created by the blow through. Mr. Ieraci went on to inform the QA Inspector once the seal or root pass is established, the weld joint will be welded with SMAW to create subsequent root/fill pass then completed with SAW.
