DEPARTMENT OF TRANSPORTATION

Quality Assurance and Source Inspection

Contract #: 04-0120F4Cty: SF/ALA Rte: 80 PM: 13.2/13.9File #: 1.28**WELDING INSPECTION REPORT****Resident Engineer:** Siegenthaler, Peter**Address:** 333 Burma Road**City:** Oakland, CA 94607**Report No:** WIR-016815**Date Inspected:** 15-Sep-2010**Project Name:** SAS Superstructure**OSM Arrival Time:** 900**Prime Contractor:** American Bridge/Fluor Enterprises, a JV**OSM Departure Time:** 1730**Contractor:** American Bridge/Fluor Enterprises, a JV**Location:** Jobsite**CWI Name:** See below**CWI Present:** Yes No**Inspected CWI report:** Yes No N/A**Rod Oven in Use:** Yes No N/A**Electrode to specification:** Yes No N/A**Weld Procedures Followed:** Yes No N/A**Qualified Welders:** Yes No N/A**Verified Joint Fit-up:** Yes No N/A**Approved Drawings:** Yes No N/A**Approved WPS:** Yes No N/A**Delayed / Cancelled:** Yes No N/A**Bridge No:** 34-0006**Component:** SAS OBG**Summary of Items Observed:**

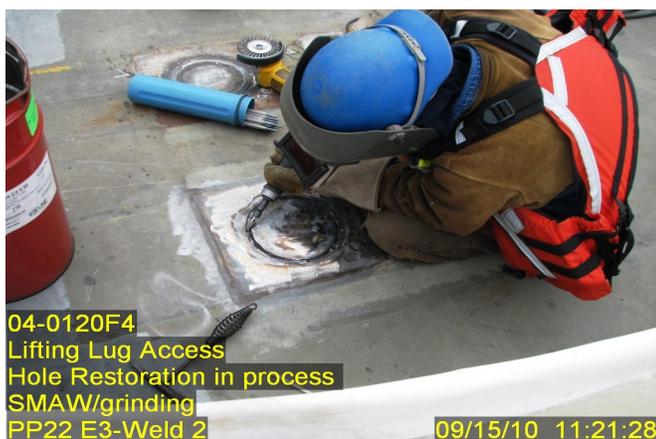
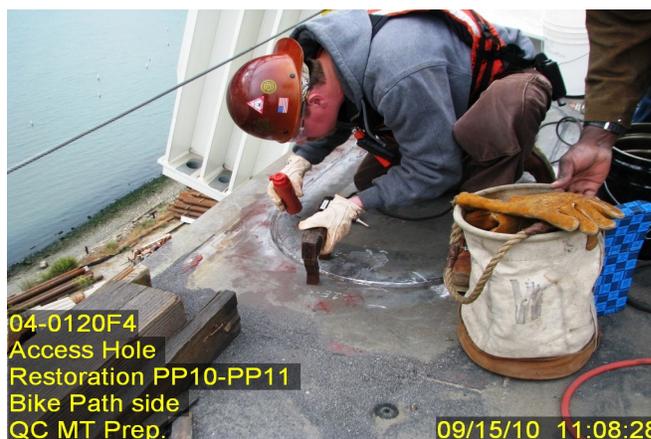
The QAI periodically observed AB/F approved welder Fred Kaddu (ID 2188) performing grinding to prepare the exterior groove for welding per the SMAW process in the 1G (flat) position. The QAI observed QC Inspector Mr. Steve McConnell performing Magnetic Particle Testing (MT) of the prepared groove. The QAI observed that the performance and evaluation of the MT appeared to comply with the MT procedure identified as SE-MT-CT-D1.5-101 Rev. 4. See photo below. The QAI noted that the QC Inspector was observing and marking areas with MT indication present in the bottom of the groove. The QAI spoke with Mr. McConnell. See Summary of Conversations below. The QAI then periodically observed Mr. Kaddu welding the root pass from the exterior of the A deck between PP10 & PP11 on the Bike Path side of OBG 1E. QC Inspector Steve McConnell was periodically present to monitor the progress and verify that the welding parameters were within the limits established by the approved welding Procedure Specification (WPS) identified as ABF-WPS-D1.5-1030 rev.1. When the root pass was completed by Mr. Kaddu the QAI observed QC Inspector Mr. Steve McConnell performing Magnetic Particle Testing (MT) of the root pass. The QAI observed that the performance and evaluation of the MT appeared to comply with the MT procedure identified as SE-MT-CT-D1.5-101 Rev. 4. The QAI periodically observed that the grinding to prepare, MT of the excavated area and welding of the root pass was repeated on the Crossbeam side of OBG 1E at the A deck between PP10 & PP11. The QAI observed that the work appeared to be in general compliance with contract documents.

The QAI asked Mr. McConnell if the indications being marked were to be ground to clear and then re-examined

by MT. Mr. McConnell stated that the depth of the indications were all deeper than the thickness of the 20mm A deck plate. He stated that the indications were in the backing weld previously deposited from the interior and that Mr. Kaddu would weld a root pass and that QC would MT the root. He also said that the interior back weld will be flush ground and MT examined after welding is completed.
