DEPARTMENT OF TRANSPORTATION

Contract #: 04-0120F4Cty: SF/ALA Rte: 80 PM: 13.2/13.9File #: 1.28**WELDING INSPECTION REPORT****Resident Engineer:** Siegenthaler, Peter**Address:** 333 Burma Road**City:** Oakland, CA 94607**Report No:** WIR-016816**Date Inspected:** 16-Sep-2010**Project Name:** SAS Superstructure**OSM Arrival Time:** 900**Prime Contractor:** American Bridge/Fluor Enterprises, a JV**OSM Departure Time:** 1730**Contractor:** American Bridge/Fluor Enterprises, a JV**Location:** Jobsite**CWI Name:** See below**CWI Present:** Yes No**Inspected CWI report:** Yes No N/A**Rod Oven in Use:** Yes No N/A**Electrode to specification:** Yes No N/A**Weld Procedures Followed:** Yes No N/A**Qualified Welders:** Yes No N/A**Verified Joint Fit-up:** Yes No N/A**Approved Drawings:** Yes No N/A**Approved WPS:** Yes No N/A**Delayed / Cancelled:** Yes No N/A**Bridge No:** 34-0006**Component:** SAS OBG**Summary of Items Observed:**

WELDING INSPECTION REPORT

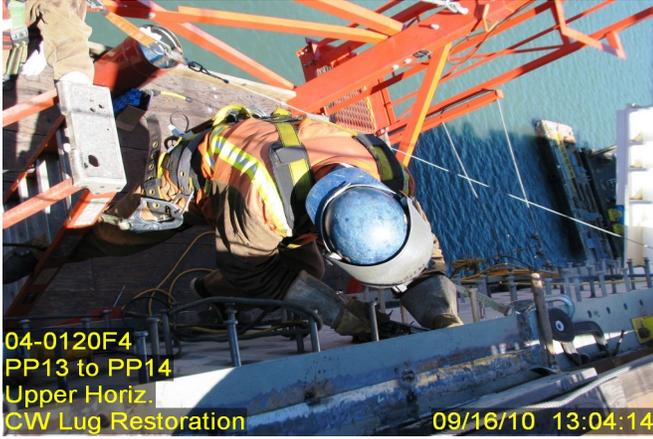
The QAI periodically observed AB/F approved welder Rick Clayborn (ID 2773) performing CJP welding per the Shielded Metal Arc Welding (SMAW) process in the 1G (Flat) and 4G (overhead) position to restore a portion of the counter weight assembly upper lug at the edge plate at W1. See photo below. QC Inspector Mike Johnson was periodically present to monitor the progress and verify that the welding parameters were within the limits established by the approved welding Procedure Specification (WPS) identified as ABF-WPS-D1.5-1000. The QAI observed that the work appeared to be in general compliance with contract documents.
