Contract #: 04-0120F4Cty: SF/ALA Rte: 80 PM: 13.2/13.9File #: 1.28**WELDING INSPECTION REPORT****Resident Engineer:** Siegenthaler, Peter**Address:** 333 Burma Road**City:** Oakland, CA 94607**Report No:** WIR-016818**Date Inspected:** 13-Sep-2010**Project Name:** SAS Superstructure**OSM Arrival Time:** 1000**Prime Contractor:** American Bridge/Fluor Enterprises, a JV**OSM Departure Time:** 1830**Contractor:** American Bridge/Fluor Enterprises, a JV**Location:** Job Site

WELDING INSPECTION REPORT

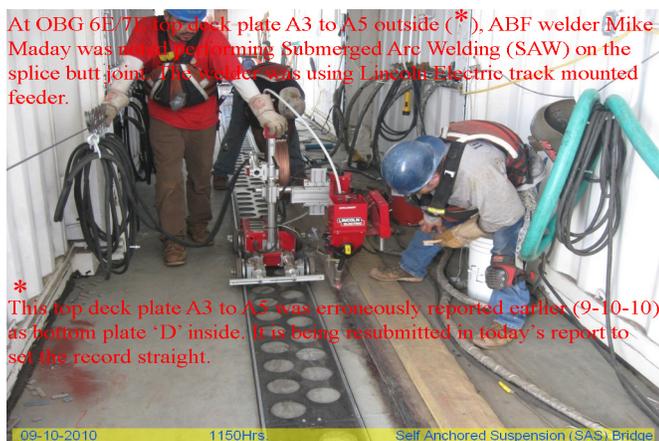
At OBG 6E/7E top deck plate A3 to A5 outside (*), ABF welder Mike Maday was noted performing Submerged Arc Welding (SAW) on the splice butt joint. The welder was using Lincoln Electric track mounted feeder.

* This top deck plate A3 to A5 was erroneously reported earlier (9-10-10) as bottom plate 'D' inside. It is being resubmitted in today's report to set the record straight.

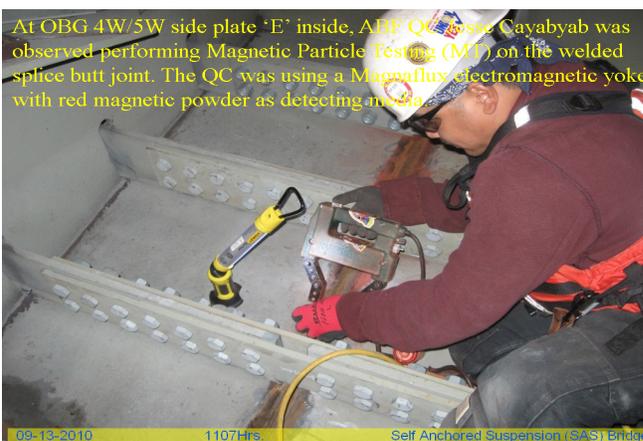
At OBG 4W/5W side plate 'E' inside, QA randomly observed ABF QC Jesse Cayabyab perform Magnetic Particle Testing (MT) on the welded splice butt joint. The QC was also noted performing visual test (VT) on the joint as he goes on with the MT. The QC was using Magnaflux electromagnetic yoke with red magnetic powder as detecting media. QC has completed the VT and MT on the joint and afterwards he informed QA that he found no significant defects during the tests.

At OBG 4W/5W side plate 'E' inside, ABF QC Jesse Cayabyab was observed performing Magnetic Particle Testing (MT) on the welded splice butt joint. The QC was using a Magnaflux electromagnetic yoke with red magnetic powder as detecting media.

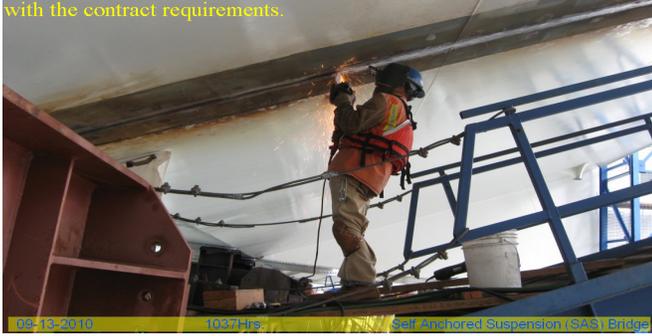
At OBG 4W/5W side plates 'C' and 'E' outside, ABF personnel were observed flush grinding the weld cover reinforcement of the splice butt joint as required. The personnel were using the 9" disc grinder with the grinding cut of the disc to the plate parallel to the direction of the bridge complying with the contract requirements. At the end of the shift, flush grinding of the weld cover reinforcement was completed on side plate 'E' and ready for ABF QC NDT. At the other side plate 'C', flush grinding of the weld cover reinforcement was still continuing and should continue tomorrow.

At OBG 4W/5W side plate "E" outside, ABF welder Huang Jin Quan was noted flush grinding the weld cover reinforcement of the splice butt joint as required. The welder was using a 9" grinder with the grinding cut to the plate parallel to the direction of the bridge complying with the contract requirements.

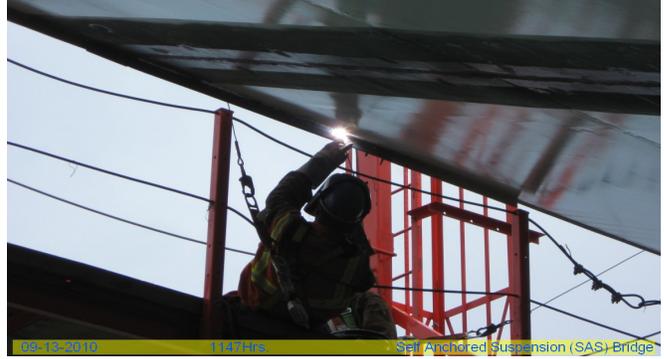
At OBG 2W side plate 'C' outside, QA randomly observed ABF welder Rick Clayborn continuing to perform fillet and partial joint penetration (PJP) welding in 2F/2G position using Shielded Metal Arc Welding (SMAW) with 1/8" diameter E7018H4R electrode. The welder was welding on 2 1/4" wide x 3/8" thick drip plate to the side plate of the OBG at panel point PP13 to PP14. The drip plate and the surface of the side plate (where the drip plate was welded) were noted ground and the paint coating removed. ABF QC Mike Johnson was noted monitoring the welding and its parameters. Before the end of the shift, fillet and PJP welding of three drip plates on mentioned above location were completed and the welder has moved to weld the bottom counter weight connection plate at the same location edge plate 'B'.

At OBG 2W side plate "E" outside, ABF welder Rick Clayborn was noted SMAW welding 2 1/4" wide x 3/8" thick drip plate to the side plate of the OBG at panel point PP13 to PP14.
