DEPARTMENT OF TRANSPORTATION

Contract #: 04-0120F4Cty: SF/ALA Rte: 80 PM: 13.2/13.9File #: 1.28**WELDING INSPECTION REPORT****Resident Engineer:** Siegenthaler, Peter**Address:** 333 Burma Road**City:** Oakland, CA 94607**Report No:** WIR-016857**Date Inspected:** 18-Sep-2010**Project Name:** SAS Superstructure**OSM Arrival Time:** 630**Prime Contractor:** American Bridge/Fluor Enterprises, a JV**OSM Departure Time:** 1500**Contractor:** American Bridge/Fluor Enterprises, a JV**Location:** Jobsite**CWI Name:** See below**CWI Present:** Yes No**Inspected CWI report:** Yes No N/A**Rod Oven in Use:** Yes No N/A**Electrode to specification:** Yes No N/A**Weld Procedures Followed:** Yes No N/A**Qualified Welders:** Yes No N/A**Verified Joint Fit-up:** Yes No N/A**Approved Drawings:** Yes No N/A**Approved WPS:** Yes No N/A**Delayed / Cancelled:** Yes No N/A**Bridge No:** 34-0006**Component:** SAS OBG**Summary of Items Observed:**

WELDING INSPECTION REPORT

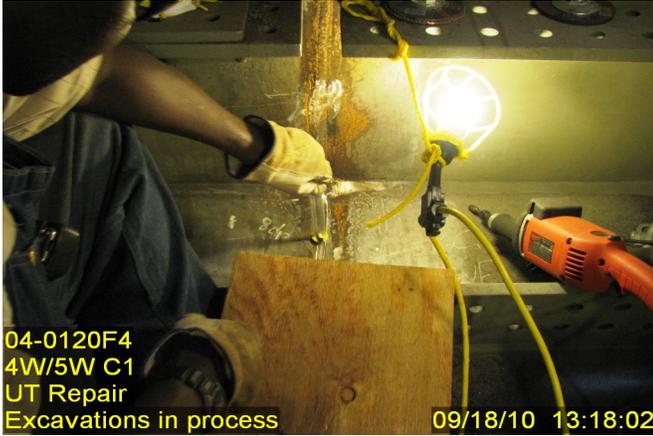
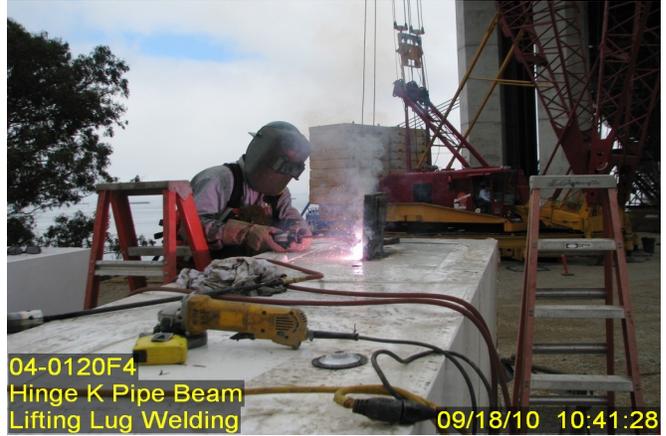
The QAI periodically observed the fit-up and welding of (2) two each lifting lugs to (4) four Hinge K Pipe beams per the FCAW-S process in the 2F (horizontal) position by AB/F approved welder Rick Clayborn (ID 2773). See photo below. QC Inspector Mike Johnson was present to monitor the progress and verify that the welding parameters were within the limits established by the approved welding Procedure Specification (WPS) identified as ABF-WPS-D1.5-F2200-2. Welding of lifting lugs to Hinge K Pipe Beams serial numbers 2244-001, 2244-002, 2244-003 and 2244-004 was completed during the shift. The QAI observed that the work at this location appeared to be in general compliance with the contract documents.
