DEPARTMENT OF TRANSPORTATION

Quality Assurance and Source Inspection

Contract #: 04-0120F4Cty: SF/ALA Rte: 80 PM: 13.2/13.9File #: 1.28**WELDING INSPECTION REPORT****Resident Engineer:** Siegenthaler, Peter**Address:** 333 Burma Road**City:** Oakland, CA 94607**Report No:** WIR-016860**Date Inspected:** 22-Sep-2010**Project Name:** SAS Superstructure**OSM Arrival Time:** 630**Prime Contractor:** American Bridge/Fluor Enterprises, a JV**OSM Departure Time:** 1500**Contractor:** American Bridge/Fluor Enterprises, a JV**Location:** Jobsite**CWI Name:** See below**CWI Present:** Yes No**Inspected CWI report:** Yes No N/A**Rod Oven in Use:** Yes No N/A**Electrode to specification:** Yes No N/A**Weld Procedures Followed:** Yes No N/A**Qualified Welders:** Yes No N/A**Verified Joint Fit-up:** Yes No N/A**Approved Drawings:** Yes No N/A**Approved WPS:** Yes No N/A**Delayed / Cancelled:** Yes No N/A**Bridge No:** 34-0006**Component:** SAS OBG**Summary of Items Observed:**

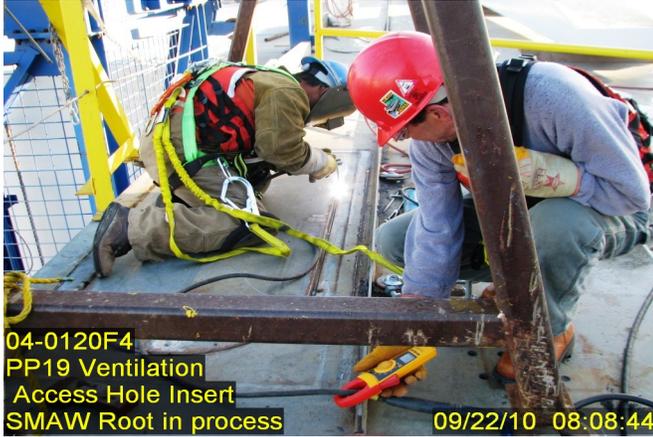
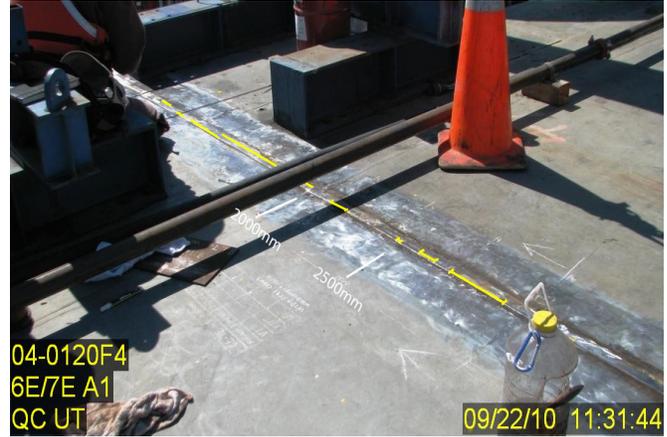
The QAI periodically observed QC Inspector Steve McConnel performing Ultrasonic Testing (UT) at weld A1. Mr. McConnel utilized the UT Procedure identified as SE-UT-D1.5-CT-100 Rev.4 during the examination of the splice weld. The QC technician performed the required longitudinal wave testing utilizing a 1" diameter transducer for base metal soundness and performed the required shear wave testing during the testing for weld soundness utilizing a .63 x .75 rectangular transducer. The work at this location was in process during this shift and the QAI observed that work appeared to be in general compliance with the contract documents. The QAI observed that Mr. McConnell had marked several indications of substantial length on the weld A1. See photo below. See Summary of Conversations below.

In conversation with QC Steve McConnell the QAI was informed that some of the indications being observed in A1 by the QC UT technician appeared to walk from the first leg into the second leg and appeared to have a considerable through wall dimension.
