DEPARTMENT OF TRANSPORTATION

Contract #: 04-0120F4Cty: SF/ALA Rte: 80 PM: 13.2/13.9File #: 99.28**WELDING INSPECTION REPORT****Resident Engineer:** Siegenthaler, Peter**Address:** 333 Burma Road**City:** Oakland, CA 94607**Report No:** WIR-016925**Date Inspected:** 27-Sep-2010**Project Name:** SAS Superstructure**OSM Arrival Time:** 700**Prime Contractor:** American Bridge/Fluor Enterprises, a JV**OSM Departure Time:** 1900**Contractor:** Zhenhua Port Machinery Company, Ltd (ZPMC)**Location:** Shanghai, China**CWI Name:** Li Yang and Zhu Zhong Hai**CWI Present:** Yes No**Inspected CWI report:** Yes No N/A**Rod Oven in Use:** Yes No N/A**Electrode to specification:** Yes No N/A**Weld Procedures Followed:** Yes No N/A**Qualified Welders:** Yes No N/A**Verified Joint Fit-up:** Yes No N/A**Approved Drawings:** Yes No N/A**Approved WPS:** Yes No N/A**Delayed / Cancelled:** Yes No N/A**Bridge No:** 34-0006**Component:** OBG Trial Assembly**Summary of Items Observed:**

WELDING INSPECTION REPORT

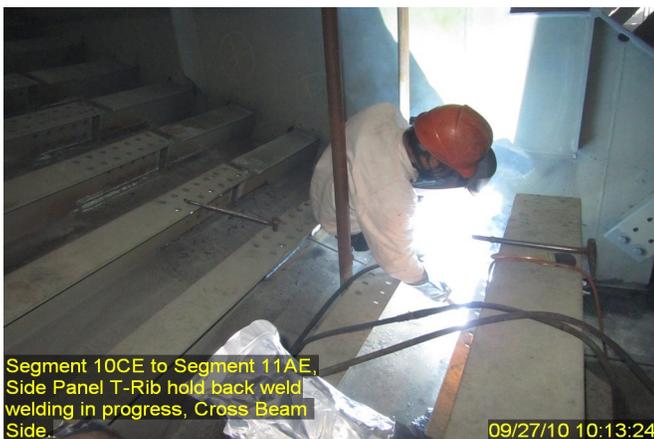
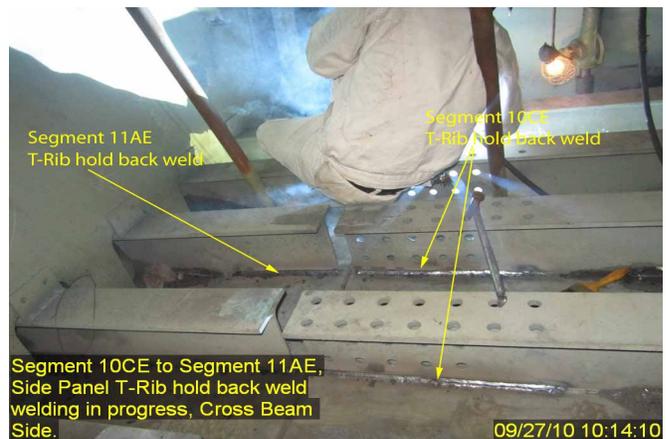
This QA Inspector observed the in-process fillet welding by Flux Cored Arc Welding (FCAW) process. The weld joint was designated as SP633-001-043/044, SP633-001-045/046 and SP633-001-047/048. The welder identification was 040458 and observed welding in the 2F (Horizontal) position using approved Welding Procedure Specification WPS-B-T-2132. The piece mark was identified as Side Panel T-Rib hold back weld, Cross Beam side. Please reference the pictures attached for more comprehensive details.

This QA Inspector observed the in-process fillet welding by Flux Cored Arc Welding (FCAW) process. The weld joint was designated as SP634-001-001/002, SP634-001-003/004 and SP634-001-005/006. The welder identification was 040458 and observed welding in the 2F (Horizontal) position using approved Welding Procedure Specification WPS-B-T-2132. The piece mark was identified as Side Panel T-Rib hold back weld, Cross Beam side. Please reference the pictures attached for more comprehensive details.
