DEPARTMENT OF TRANSPORTATION

Contract #: 04-0120F4Cty: SF/ALA Rte: 80 PM: 13.2/13.9File #: 1.28**WELDING INSPECTION REPORT****Resident Engineer:** Siegenthaler, Peter**Address:** 333 Burma Road**City:** Oakland, CA 94607**Report No:** WIR-016932**Date Inspected:** 22-Sep-2010**Project Name:** SAS Superstructure**OSM Arrival Time:** 1000**Prime Contractor:** American Bridge/Fluor Enterprises, a JV**OSM Departure Time:** 1830**Contractor:** American Bridge/Fluor Enterprises, a JV**Location:** Job Site

WELDING INSPECTION REPORT

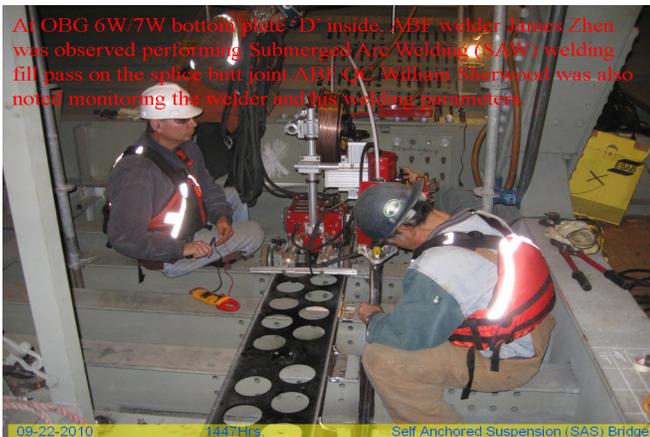
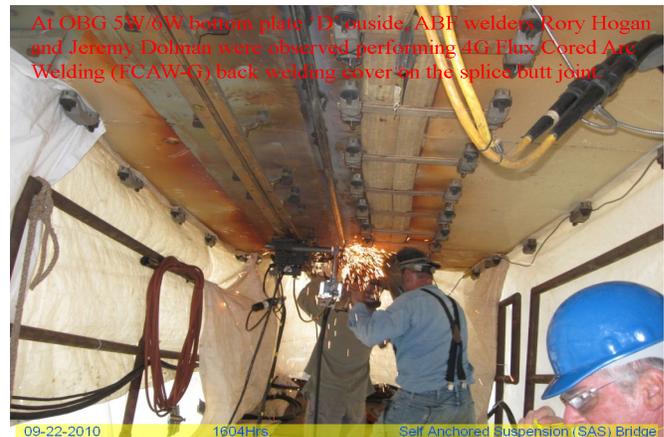
QA randomly observed ABF/JV qualified welders Rory Hogan (ID #3186) and Jeremy Dolman (ID #5042) continuing to perform complete joint penetration (CJP) groove (splice) back welding fill to cover pass on OBG 5W/6W bottom plate 'D' outside. The welder was observed welding in the 4G (overhead) position utilizing a dual shield Flux Cored Arc Welding (FCAW-G) with E71T-1M, 1/16" diameter wire electrode and implementing Caltrans approved Welding Procedure Specification (WPS) ABF-WPS-D15-3110-4. The welder was using a track mounted welder holder assembly that was remotely controlled. The joint being welded has the backing bar gouged using the Esab Plasma Arc machine and was ground smooth. The gouged and ground splice butt joint was also Non Destructive Testing (NDT) tested using the Magnetic Particle Testing (MT). The splice joint was preheated to greater than 150 degrees Fahrenheit using Miller Proheat 35 Induction Heating System located on top of the plate prior and maintained the preheat by moving the heater blankets on the side of the plate during welding. The vicinity was also properly protected from wind and other climatic changes. During welding, ABF Quality Control (QC) Mike Johnson was noted monitoring the welding parameters of the welder. At the end of the shift, fill pass welding was still continuing and should continue tomorrow.

At OBG 6W/7W bottom plate 'D', QA randomly observed ABF certified welder James Zhen ID #6001 and Songtao, Huang ID #3794 perform 1G (flat position) Submerged Arc Welding (SAW). The welders were utilizing F7A6-EM12K-H8, 3.2mm electrode with corresponding Esab OK Flux 10.62 flux and implementing Caltrans

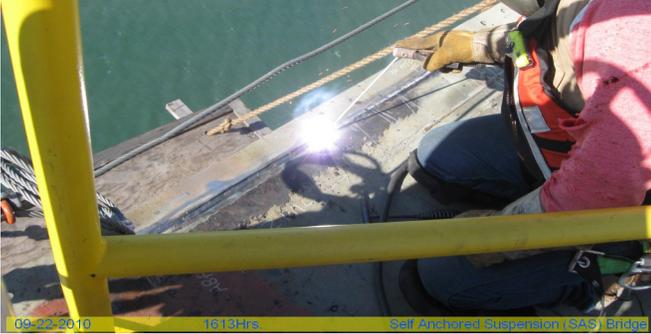
At OBG 3W top deck plate 'A' outside, ABF welder Eric Sparks was observed 1G Shielded Metal Arc Welding (SMAW) welding cover on the CJP groove joint of the 3/8" wide x 3/8" thick counter weight connection plate to the deck plate.

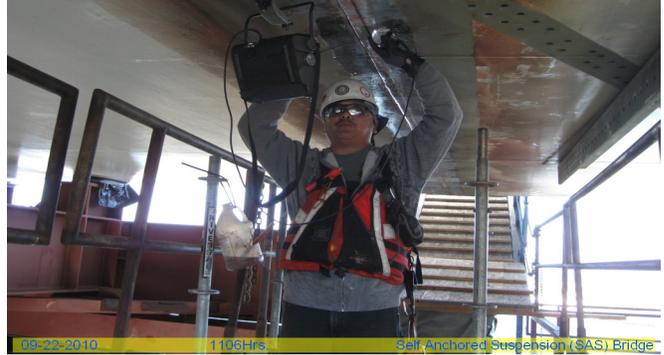
At OBG 4W/5W bottom plate 'D' outside, ABF QC Jesse Cavabyah was observed performing Ultrasonic Testing (UT) on the welded and flush ground weld cover of the splice butt joint.
