DEPARTMENT OF TRANSPORTATION

Quality Assurance and Source Inspection

Contract #: 04-0120F4Cty: SF/ALA Rte: 80 PM: 13.2/13.9File #: 69.28**WELDING INSPECTION REPORT****Resident Engineer:** Siegenthaler, Peter**Address:** 333 Burma Road**City:** Oakland, CA 94607**Report No:** WIR-016937**Date Inspected:** 14-Sep-2010**Project Name:** SAS Superstructure**OSM Arrival Time:** 700**Prime Contractor:** American Bridge/Fluor Enterprises, a JV**OSM Departure Time:** 1900**Contractor:** Zhenhua Port Machinery Company, Ltd (ZPMC), Changxing Island **Location:** Shanghai, China**CWI Name:** Mr. Zhao Chen Sun**CWI Present:** Yes No**Inspected CWI report:** Yes No N/A**Rod Oven in Use:** Yes No N/A**Electrode to specification:** Yes No N/A**Weld Procedures Followed:** Yes No N/A**Qualified Welders:** Yes No N/A**Verified Joint Fit-up:** Yes No N/A**Approved Drawings:** Yes No N/A**Approved WPS:** Yes No N/A**Delayed / Cancelled:** Yes No N/A**Bridge No:** 34-0006**Component:** Tower**Summary of Items Observed:**

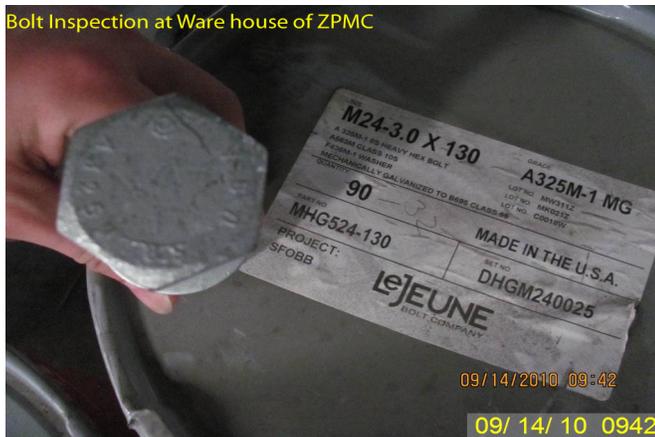
1. " This QA Inspector was instructed by Lead Inspector Albert Carreon to request that ZPMC personnel allow him to inspect the container that supplier LeJuen bolts originally shipped to ZPMC in order to ensure traceability of the bolts in question. On Saturday, 11th Sep. 2010, ZPMC representative Lai Tau refused to provide this QA Inspector or the Lead Inspector for (Doubler plate to Face B skin -M24 X 130 -64 nos) with the location of the container. These Bolts (M24 X 130 -64 nos) were offered for inspection today, This QA inspector observed that at warehouse of ZPMC, these bolts are the same which have found in paper boxes at Bay no. 11. The Rocop no. found to be DHGM240025." (Photo attached)
