DEPARTMENT OF TRANSPORTATION

Contract #: 04-0120F4Cty: SF/ALA Rte: 80 PM: 13.2/13.9File #: 69.28**WELDING INSPECTION REPORT****Resident Engineer:** Siegenthaler, Peter**Address:** 333 Burma Road**City:** Oakland, CA 94607**Report No:** WIR-016949**Date Inspected:** 08-Sep-2010**Project Name:** SAS Superstructure**OSM Arrival Time:** 700**Prime Contractor:** American Bridge/Fluor Enterprises, a JV**OSM Departure Time:** 1900**Contractor:** Zhenhua Port Machinery Company, Ltd (ZPMC), Changxing Island **Location:** Shanghai, China

Bridge No: 34-0006**Component:** Tower & OBG Components**Summary of Items Observed:**

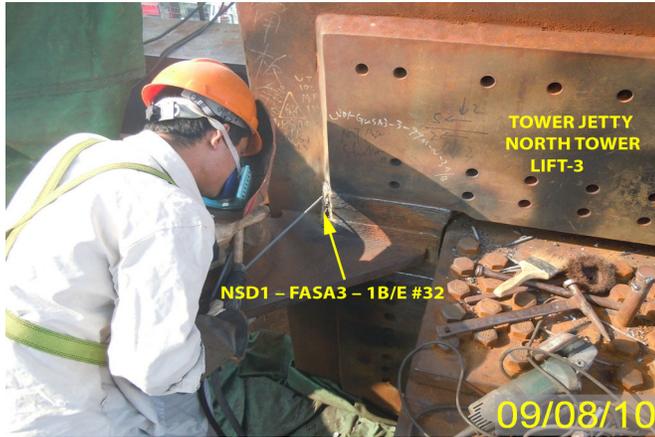
Weld joint # 32 located on North tower Lift-3, 99 M cross bracing gusset plate to small doubler plate NSD1 – FASA3 – 1B/E. Welder is identified as 040582. ZPMC Quality Control (QC) Inspector is identified Sun Zi Wang. The welding variables recorded by QC appeared to comply with the WPS – B – T – 4313– Tc – P4. (See attached photo)

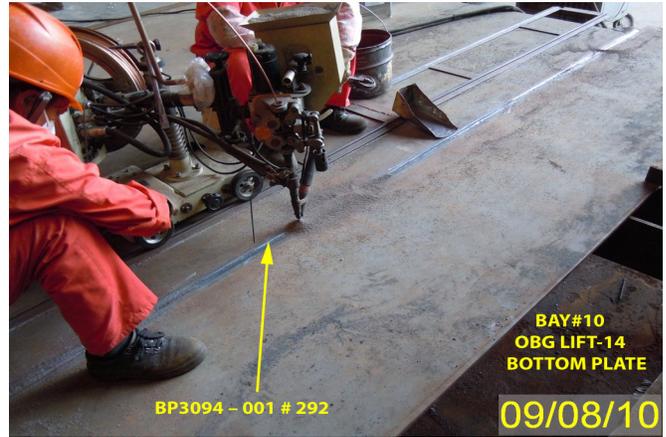
Weld joint # 292 located on BP3094 – 001 Welder is identified as 209051. ZPMC Quality Control (QC) Inspector is identified as Sun Tian Liang. The welding variables recorded by QC appeared to comply with the WPS – B – T – 2221 – B – L2c – S – 2. (See attached photo)
